AmeriSpec Inspection Services

Doc #:	COMMERCIAL SAMPLE	Inspector:	Certified Inspector
Date:	9/27/2022		
Address:	123 Main Street Any Town CA		
Client Name:	Mr. Buyer

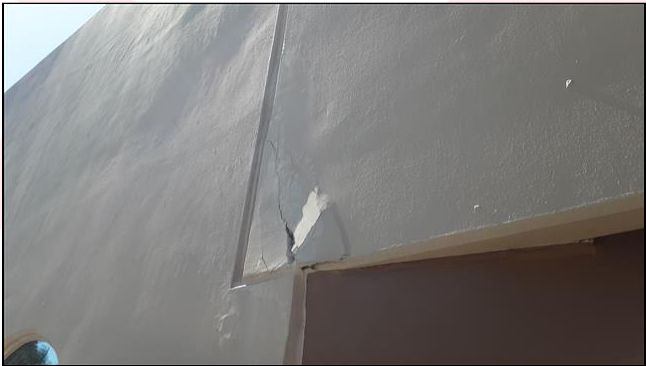
Step #	Component	Comment
1.0	Parking Lot	Condition:. Cracked asphalt noted.
1.1	Walkways/Stairs	Condition:. Common cracks and chipped concrete noted.
1.2	Walls/Fence/ Gates	N.
1.3	Siding	Condition:. Damaged areas of stucco noted. Common cracks noted.

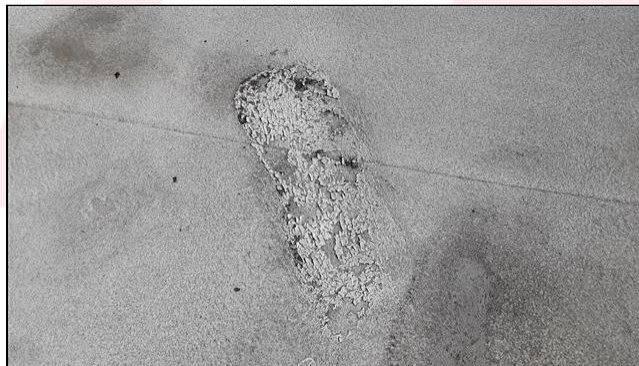
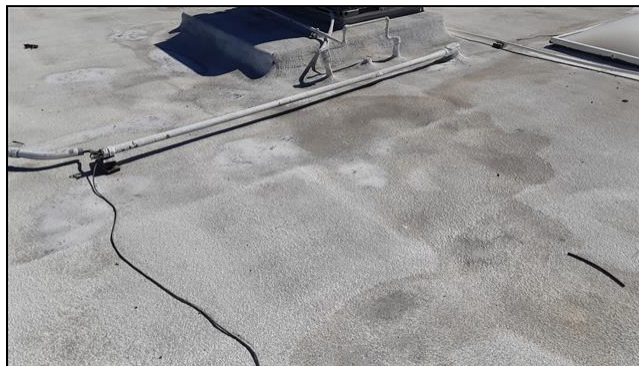
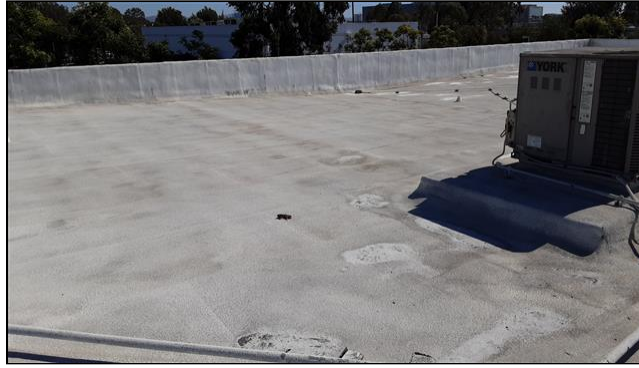
Step #	Component	Comment
2.0	Flashing	
2.1	Condition	Condition. Roof shows normal wear for its age and type. Evidence of ponding noted. This condition indicates improper drainage. Deteriorated composition noted. We suggest that the maintenance efforts be made in the few areas where roofing materials are damaged or missing. Suggest consulting a licensed roofer for further review.

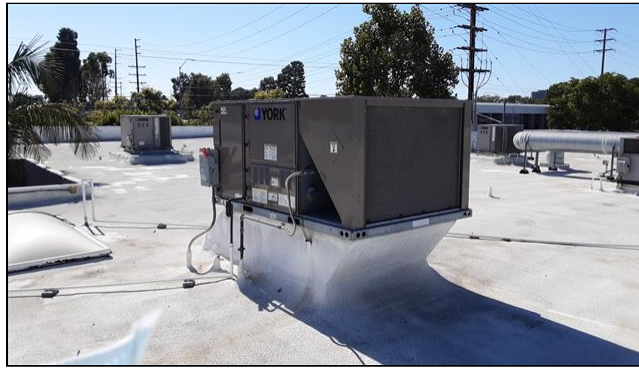
3.0 Heating **Condition: Unable to test per request of tenants.**

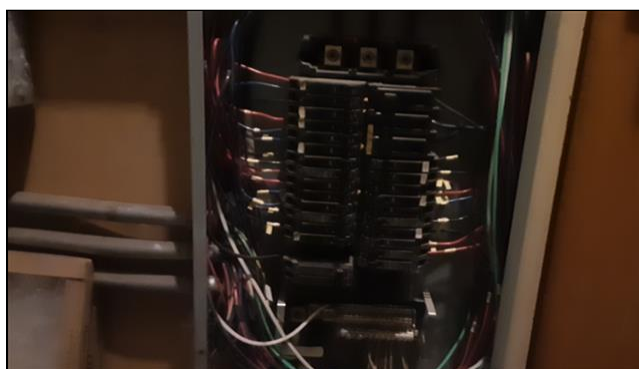
5.2 Sub Panel **Serviceable. Sub panel is located next to the main panel.**

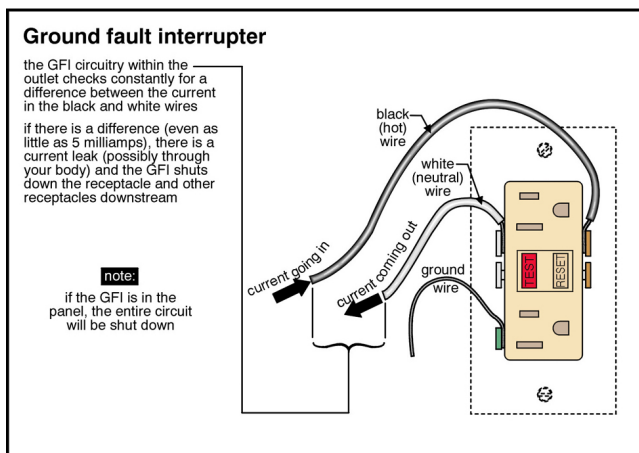
GFCI

Condition: Ground fault circuit interrupters are provided for safety. We suggest periodic testing to ensure proper working order.

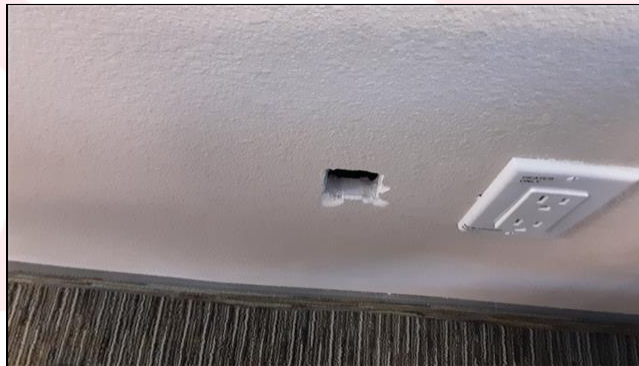
Step #	Component	Comment
9.0.E	Floors	S.
9.1.E	Walls	Condition:. Cut section noted.

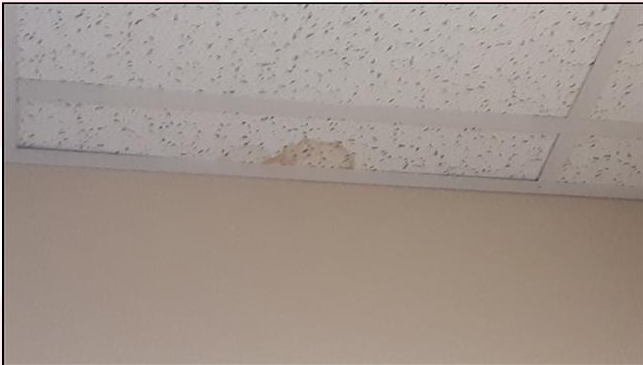
Step #	Component	Comment
10.0	Floors	S.
10.1	Walls	S.
10.2	Ceiling	Condition:. Water stains noted in rear storage closet, roof above.
