AmeriSpec Inspection Services

Doc #:	Thermal Sample	Inspector:	Certified Thermal Inspector
Date:	1/2/2023		
Address:	123 Sample Street Any Town CA 1111		
Client Name:	Mr. & Mrs. Buyer

INFRARED/THERMAL IMAGING REPORT

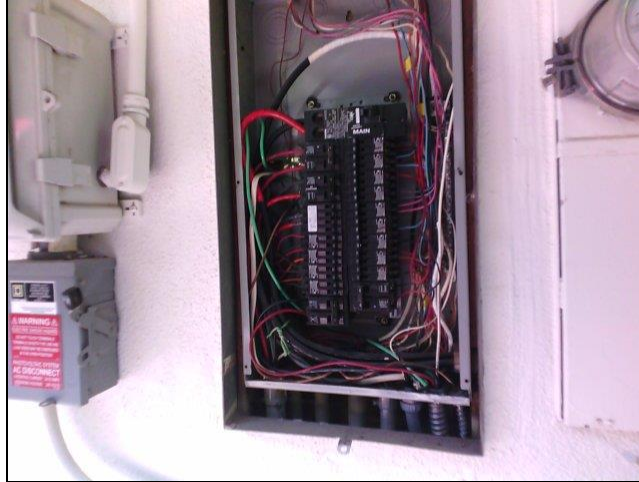
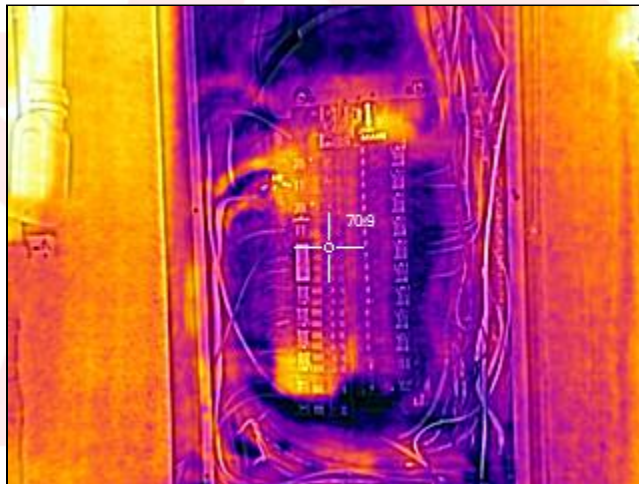
Step #	Component	Comment
1.0	Other Comments	Pictures were taken before and after the inspection was performed. No anomalies observed.

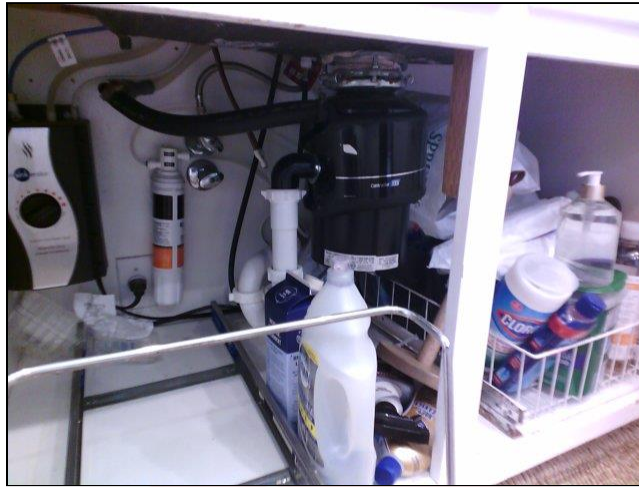
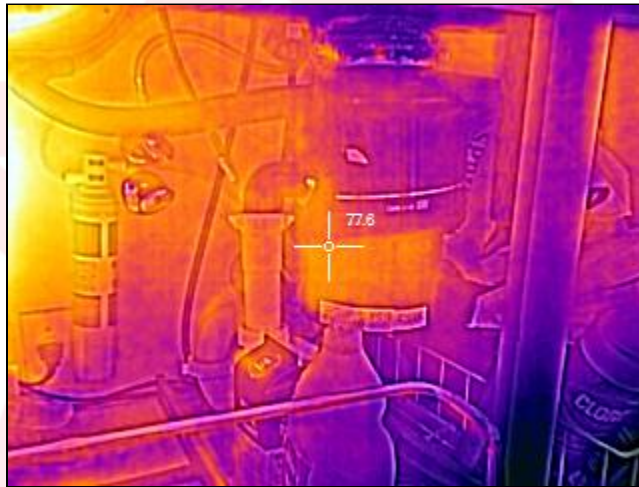
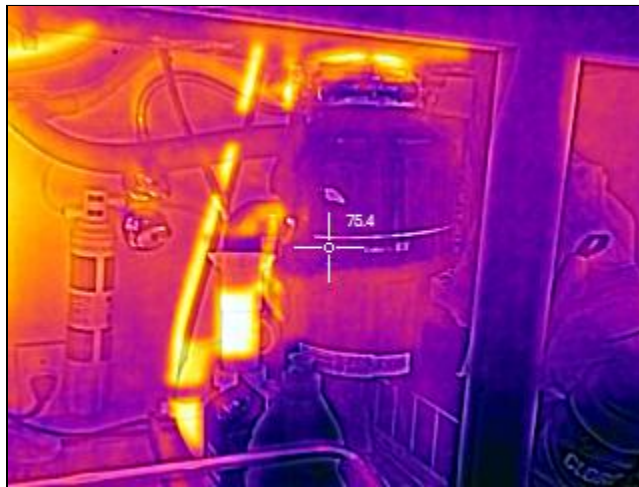
Step #	Component	Comment
2.0	Traps/Drains/Supply	Pictures were taken before and after the water was run. No thermal anomalies were observed.

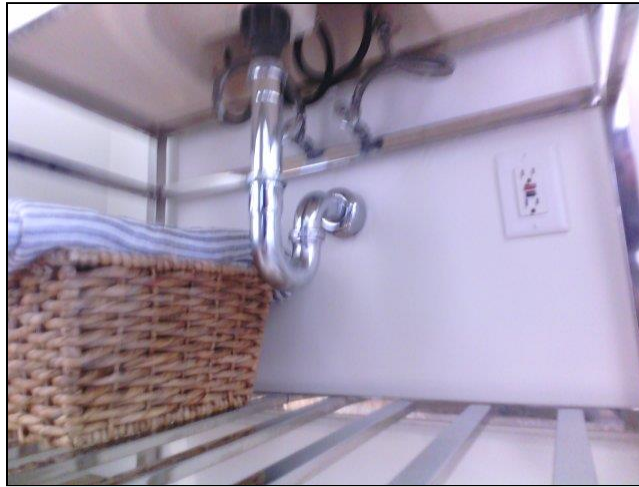
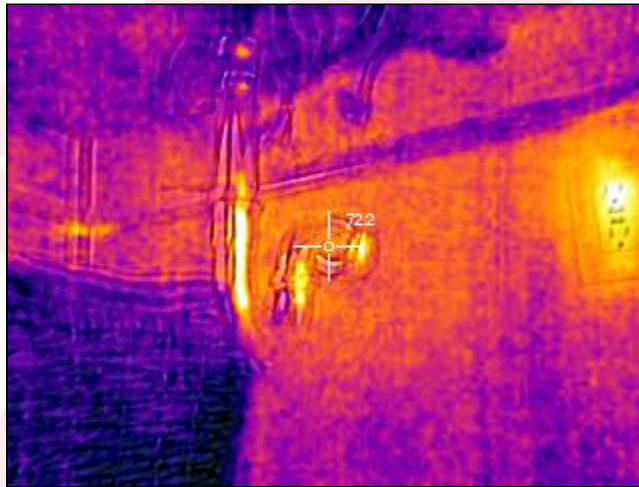
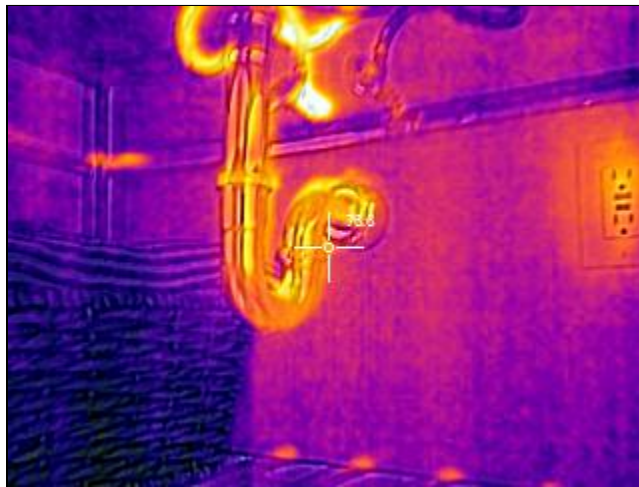
Step #	Component	Comment
3.0.A	Traps/Drains/Supply	Pictures were taken before and after the water was run. No thermal anomalies were observed.

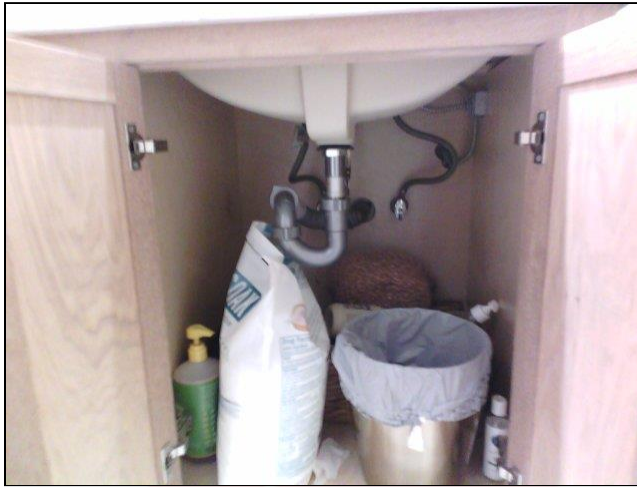
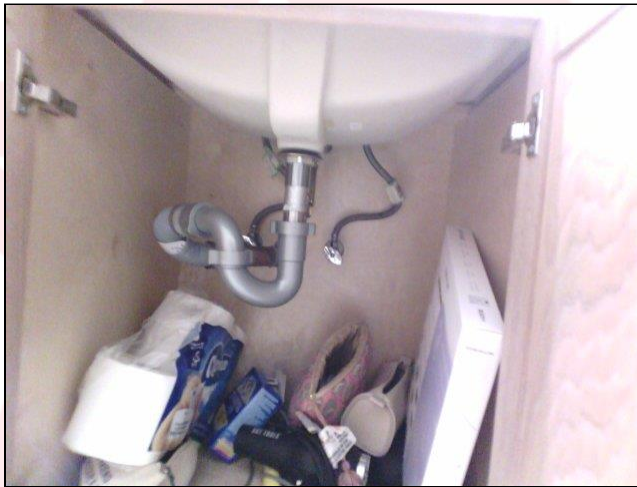
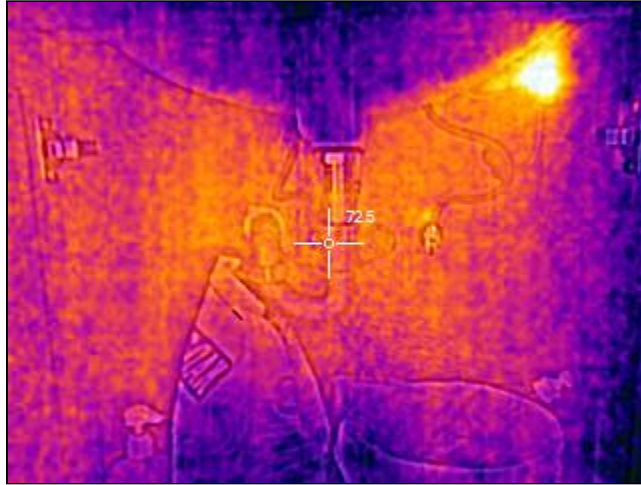
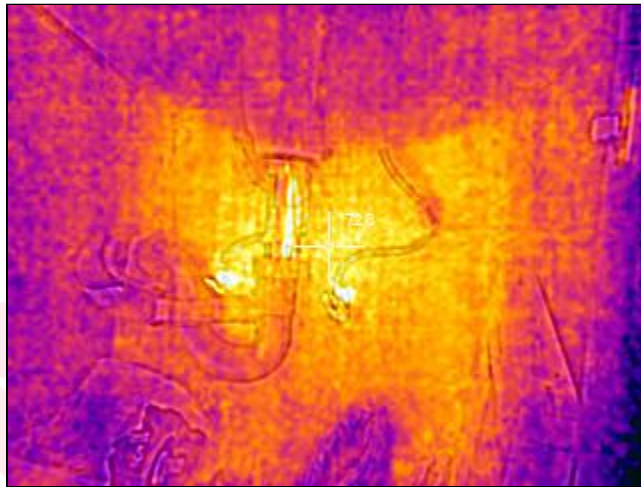
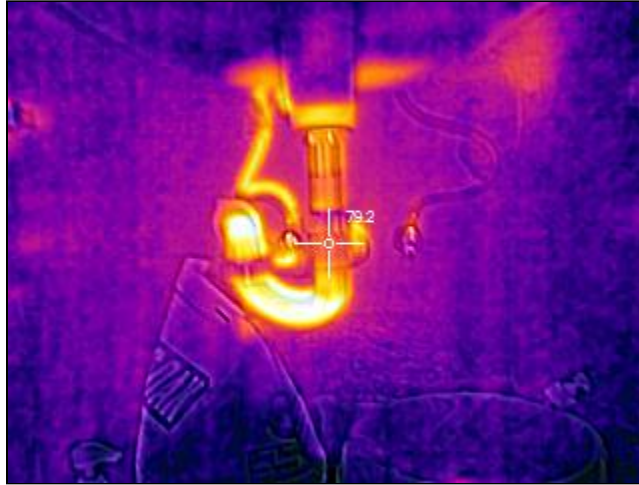
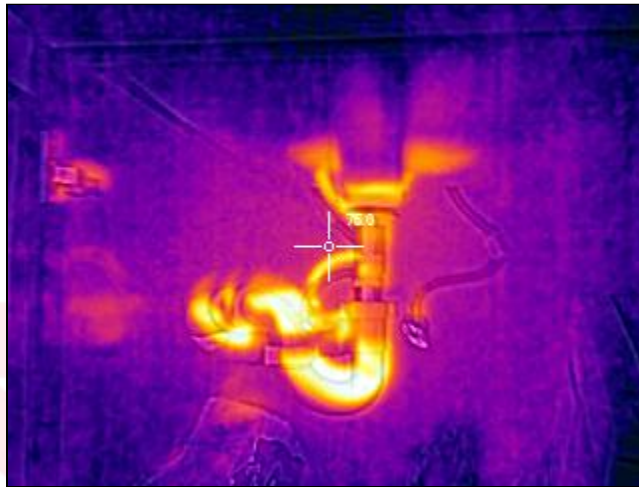
Step #	Component	Comment
3.0.B	Traps/Drains/Supply	Pictures were taken before and after the water was run. No thermal anomalies were observed.

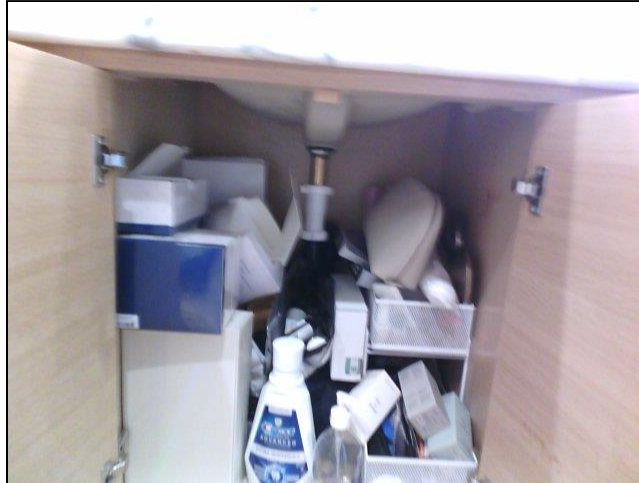
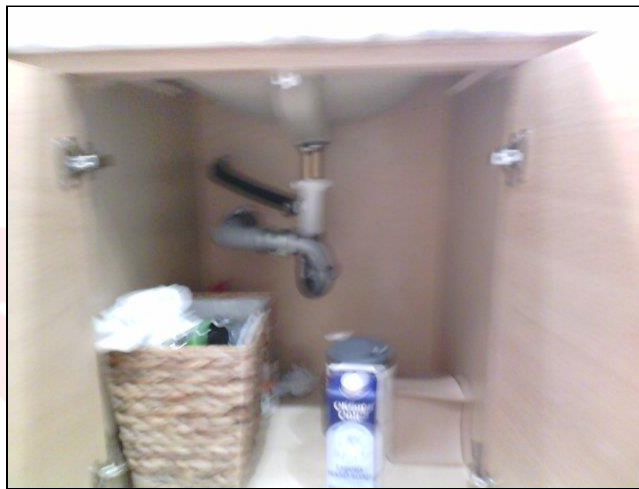
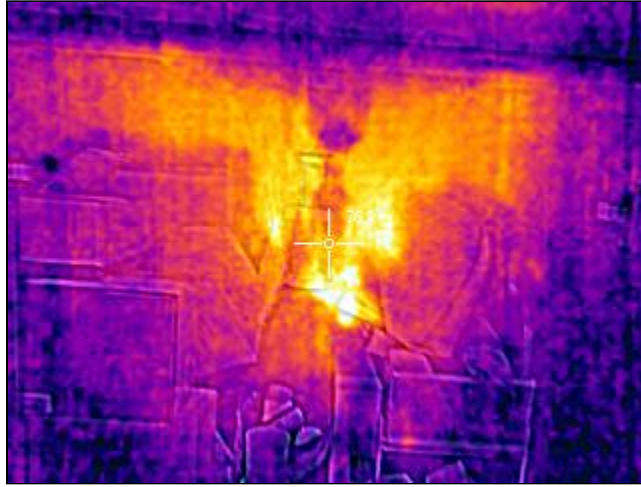
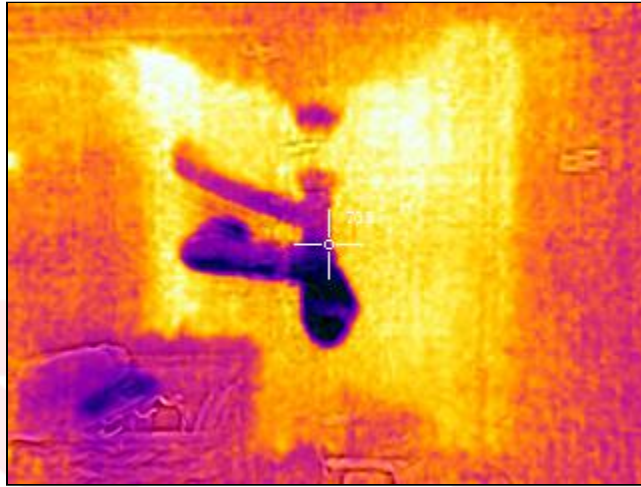
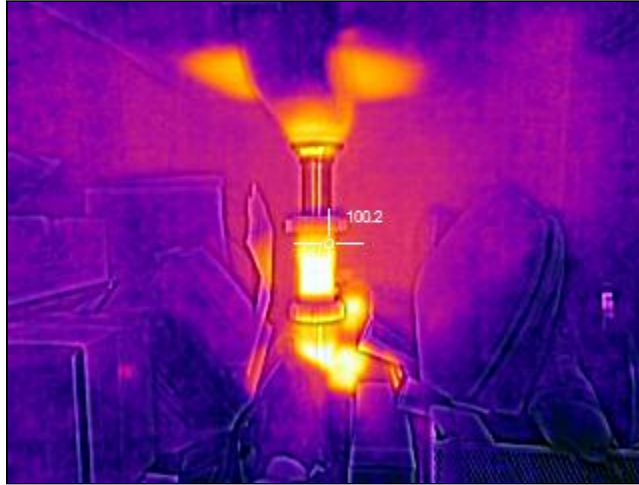
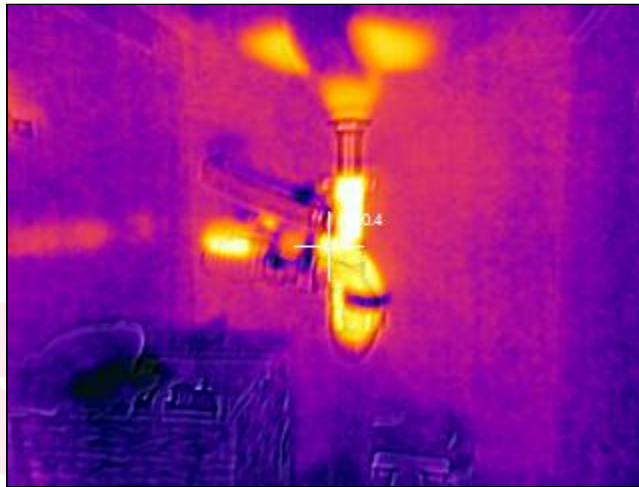
3.0.C Traps/Drains/Supply

Pictures were taken before and after the water was run. No thermal anomalies were observed.

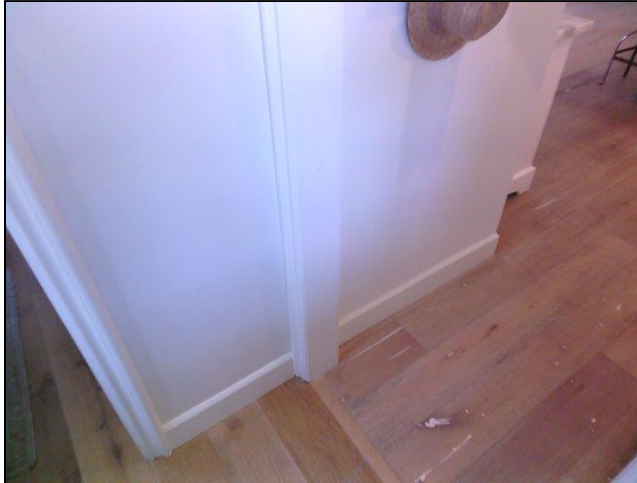
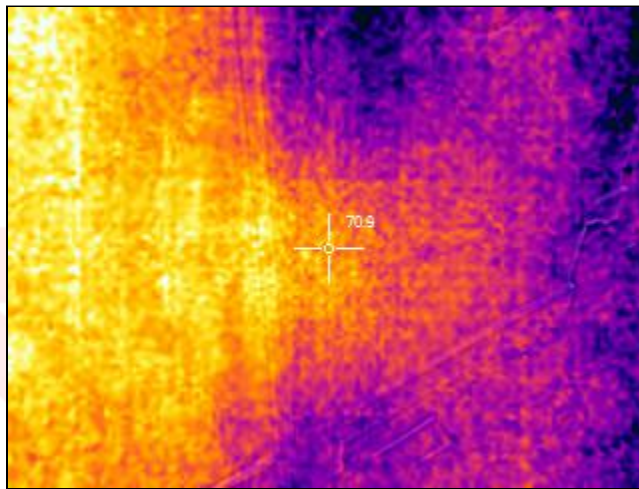
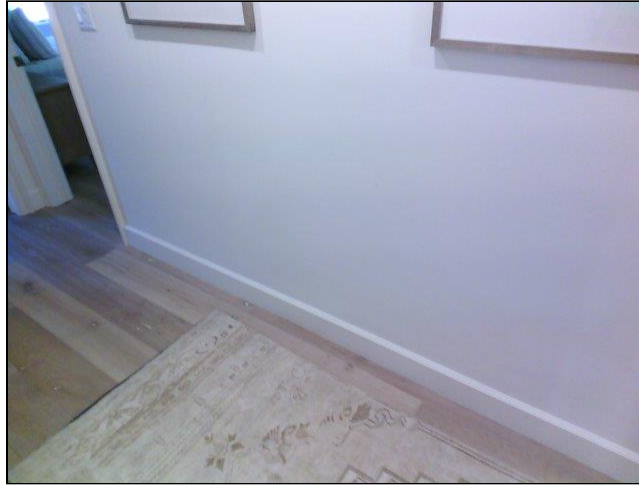
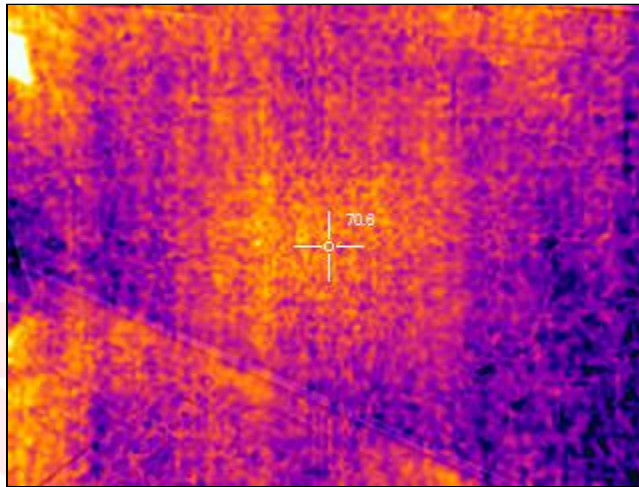
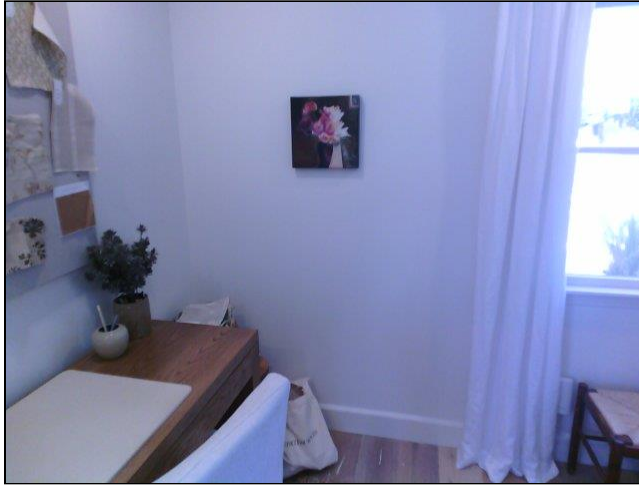
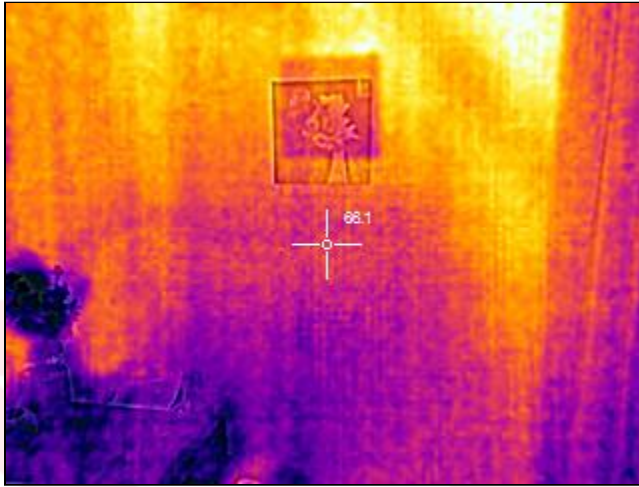
4.0 Walls

Serviceable. Area was inspected with FLIR thermal camera, no thermal anomalies were detected.
