**Orange Coast Property Services****South Coast Property Services****(949) 454-7900 -- (760) 585-2355**

Doc #: COMMERCIAL SAMPLE Inspector: Certified Inspector
Date: 9/27/2022
Address: 123 Main Street
Any Town CA
Client Name: Mr. Buyer

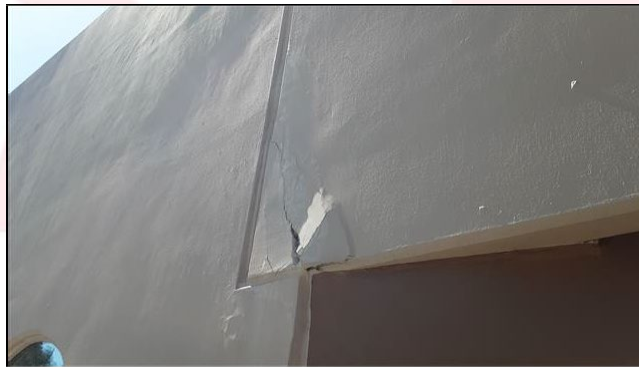
Step #	Component	Comment
1.0	Parking Lot	Condition:.. Cracked asphalt noted.
1.1	Walkways/Stairs	Condition:.. Common cracks and chipped concrete noted.
1.2	Walls/Fence/ Gates	N.
1.3	Siding	Condition:.. Damaged areas of stucco noted. Common cracks noted.

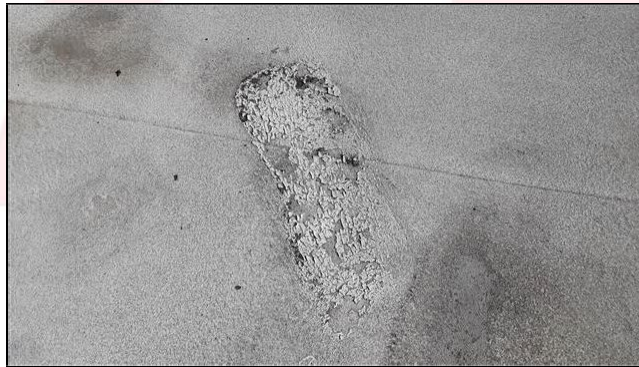
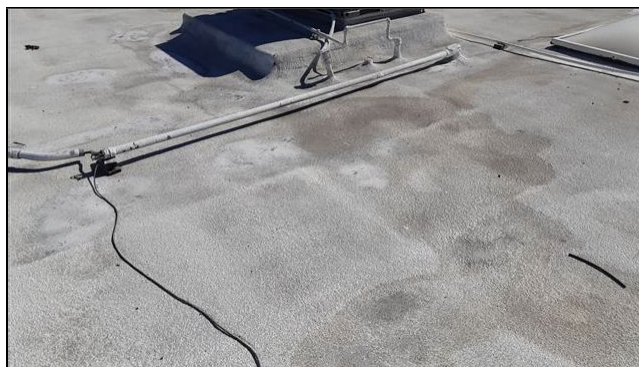
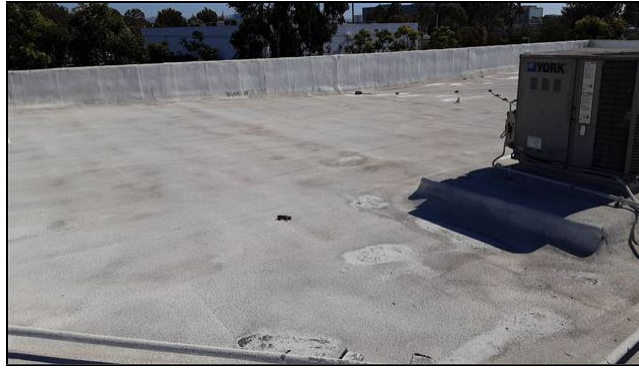
Step #	Component	Comment
2.0	Flashing	
2.1	Condition	Condition. Roof shows normal wear for its age and type. Evidence of ponding noted. This condition indicates improper drainage. Deteriorated composition noted. We suggest that the maintenance efforts be made in the few areas where roofing materials are damaged or missing. Suggest consulting a licensed roofer for further review.

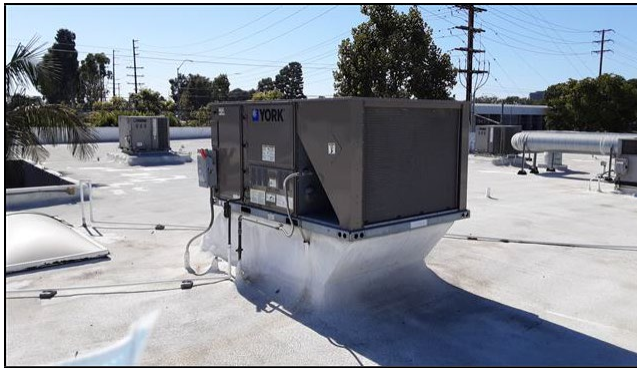
3.0 Heating **Condition: Unable to test per request of tenants.**

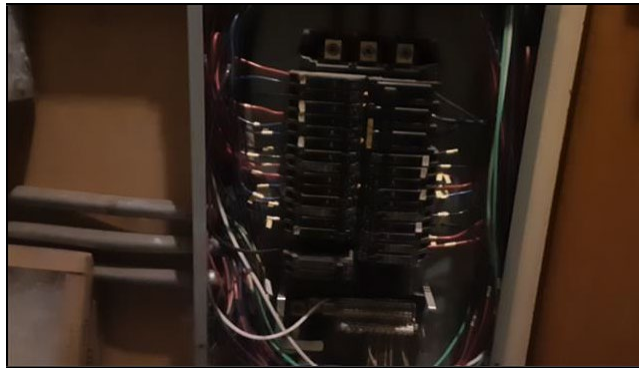
5.2 Sub Panel **Serviceable. Sub panel is located next to the main panel.**

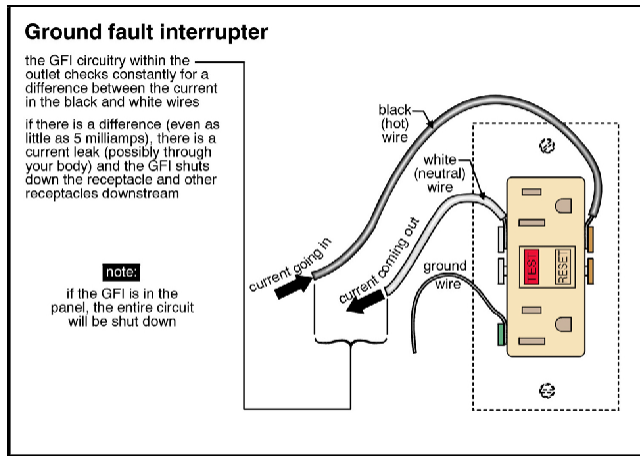
GFCI

Condition: Ground fault circuit interrupters are provided for safety. We suggest periodic testing to ensure proper working order.

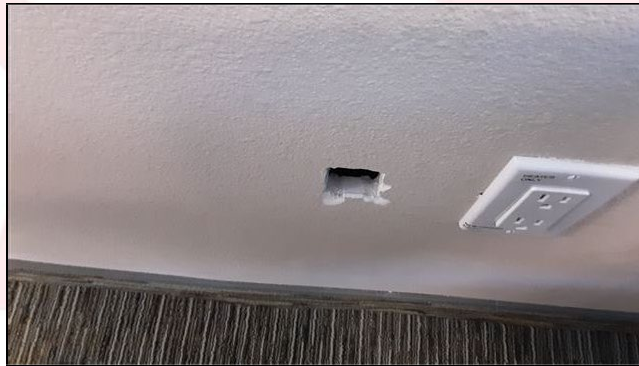
Step #	Component	Comment
9.0.E	Floors	S.
9.1.E	Walls	Condition:. Cut section noted.

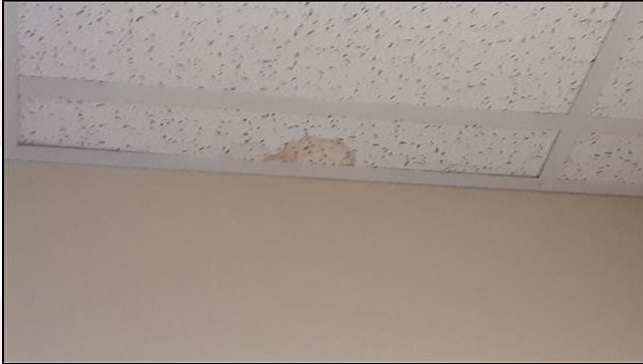
Step #	Component	Comment
10.0	Floors	S.
10.1	Walls	S.
10.2	Ceiling	Condition:.. Water stains noted in rear storage closet, roof above.
