Doc #: DRONE SAMPLE Inspector: Licensed Drone Pilot

Date: 3/7/2024

Address: 123 Main Street, Anytown, CA

DRONE ROOF

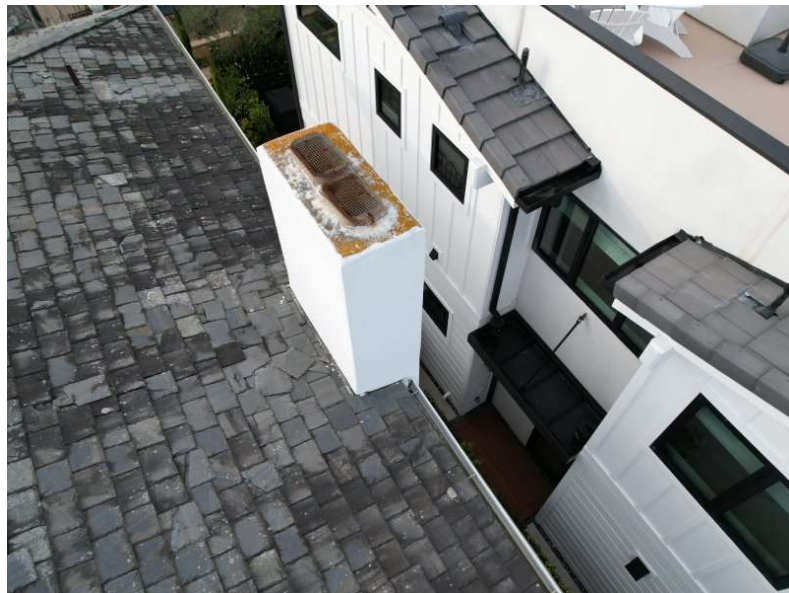
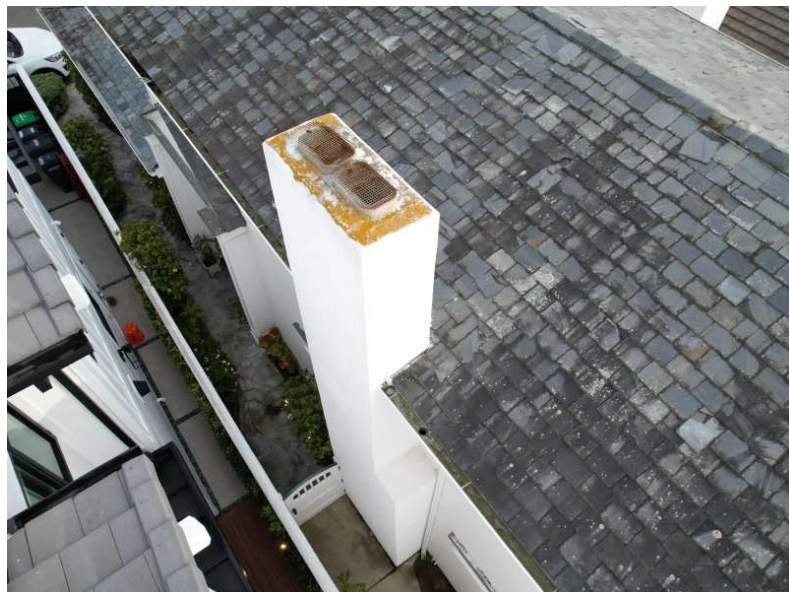
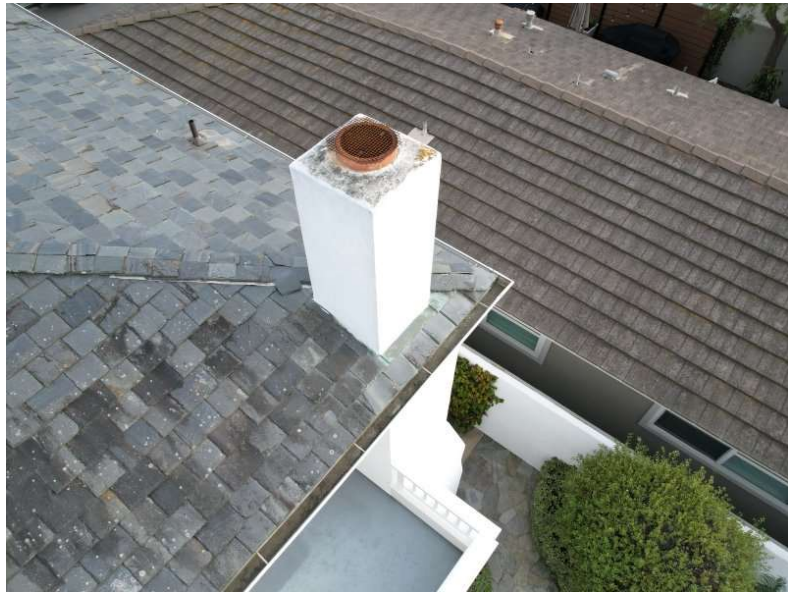
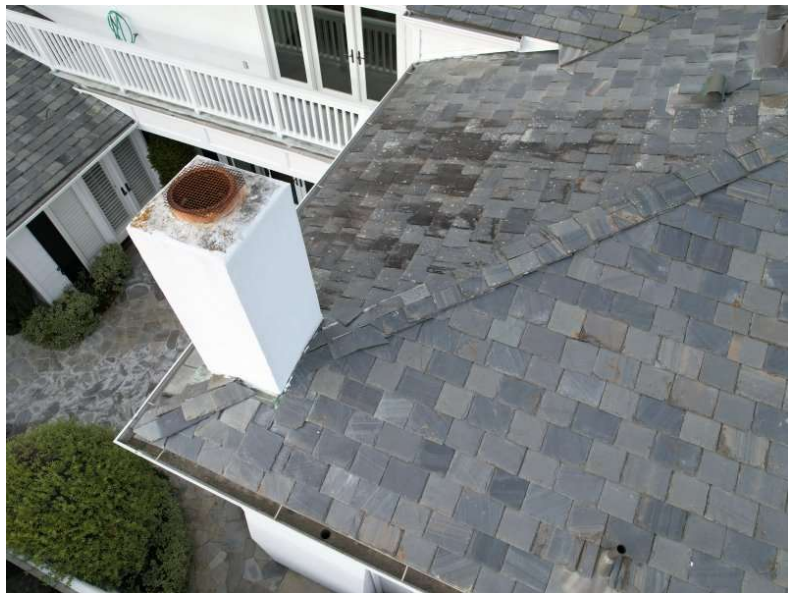
Step #	Component	Comment
111..	Chimney	Spark arresters are installed as a safety feature.

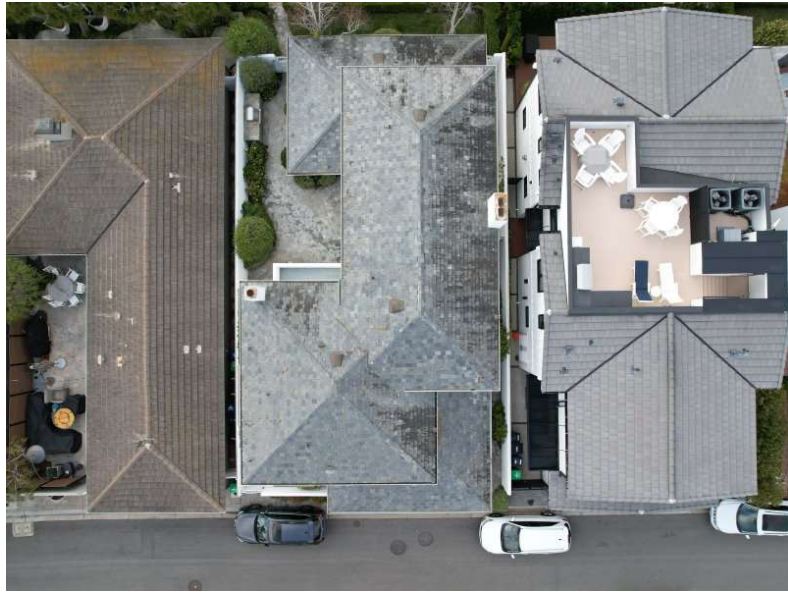
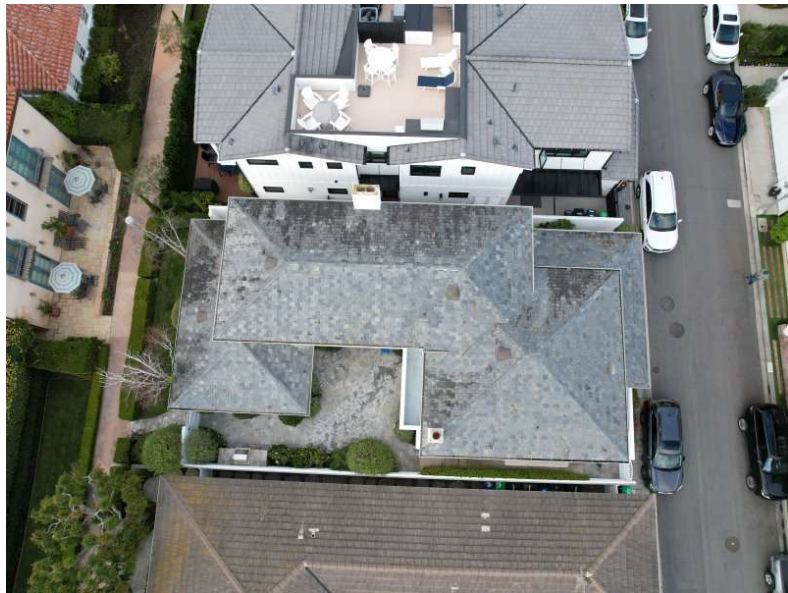
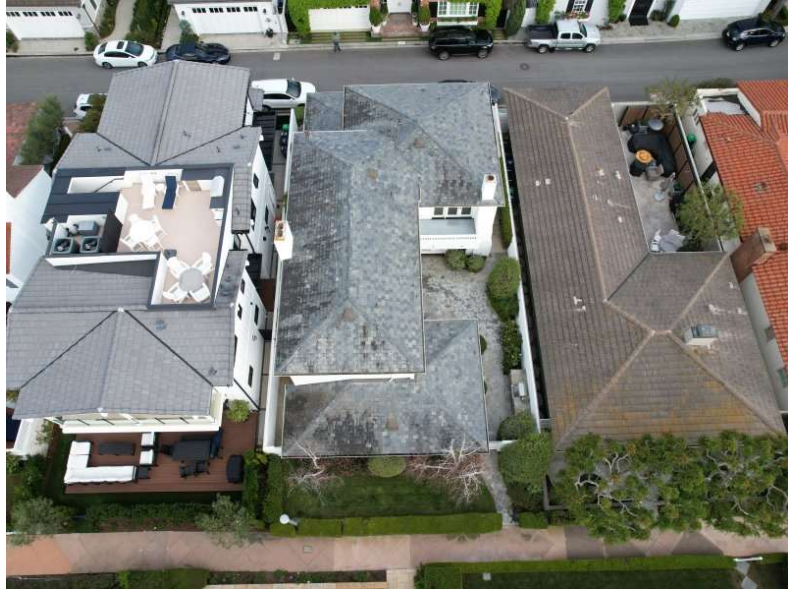
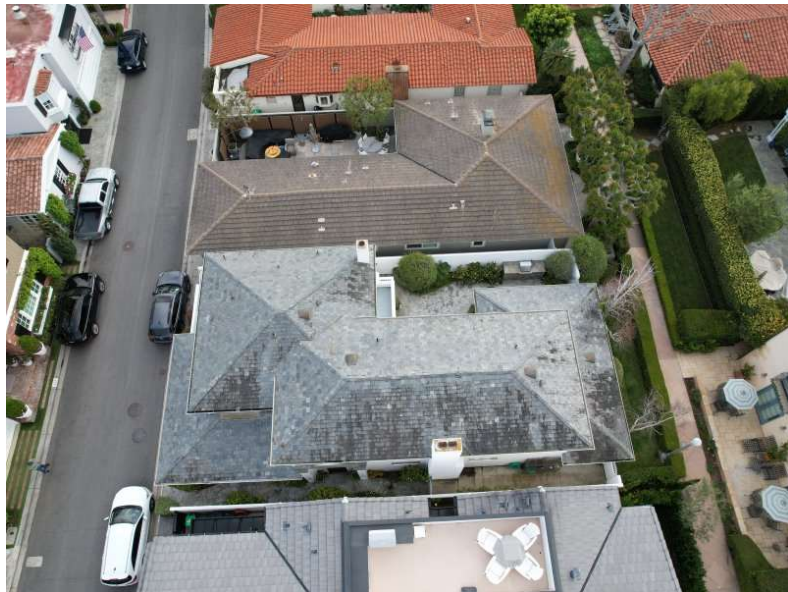
Step #	Component	Comment
126..	Type/Material	Hip; slate. Observed from the air using a drone.

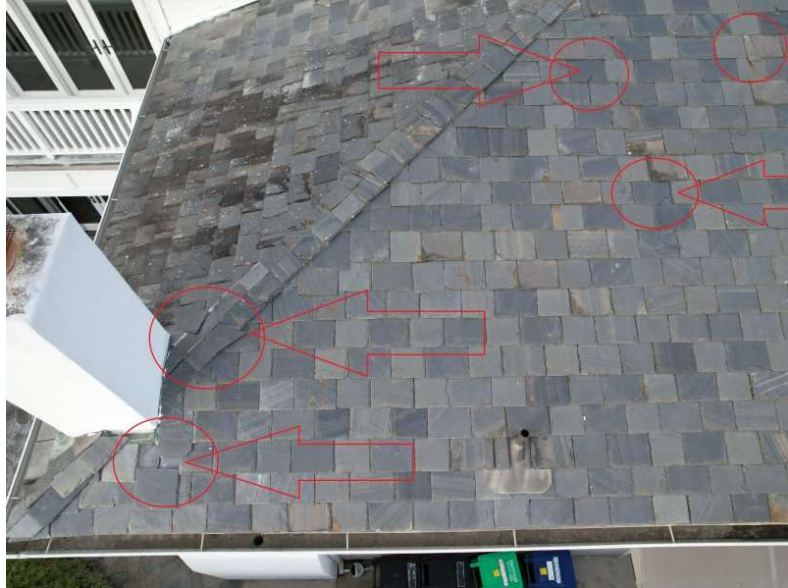
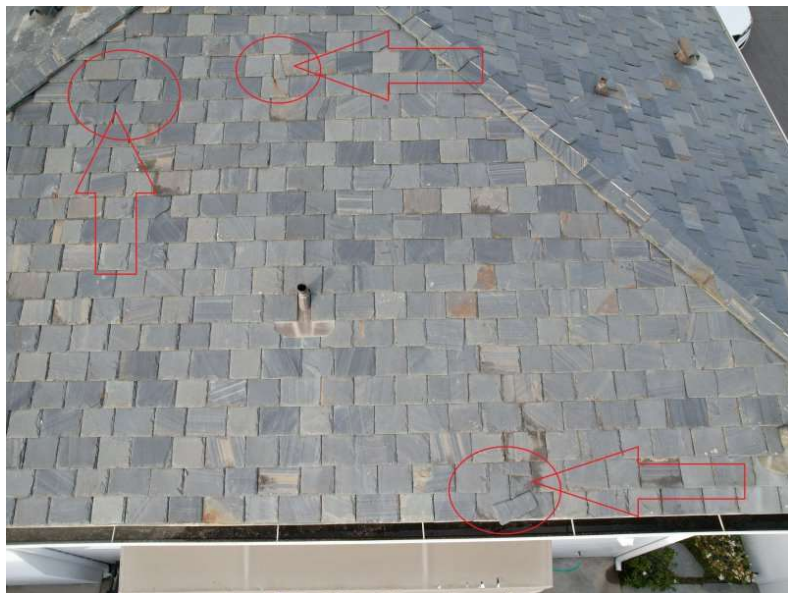
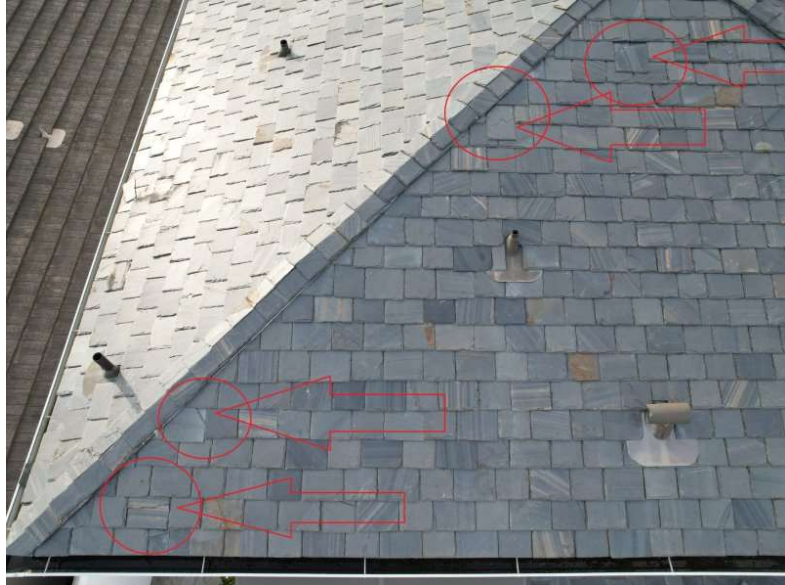
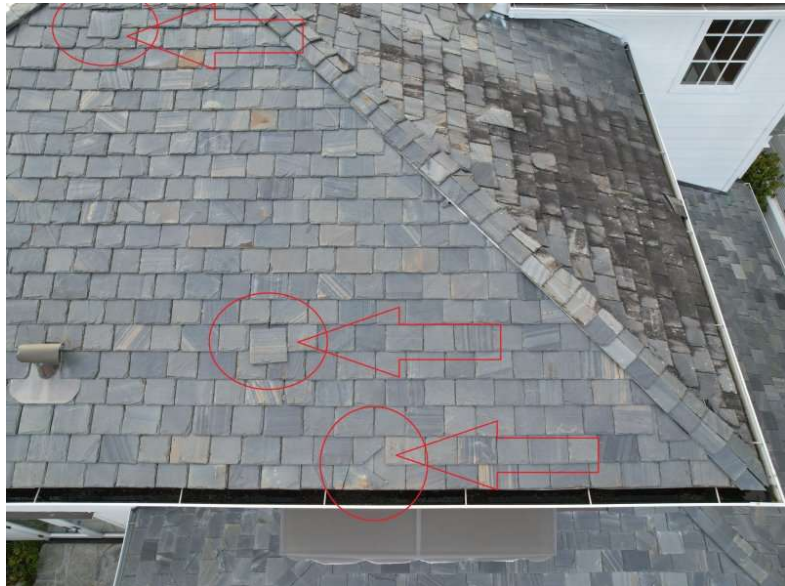
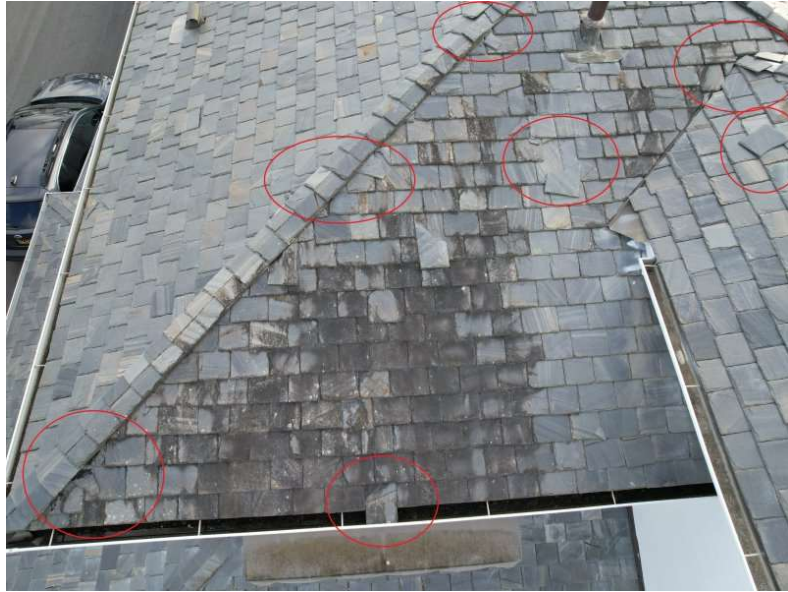
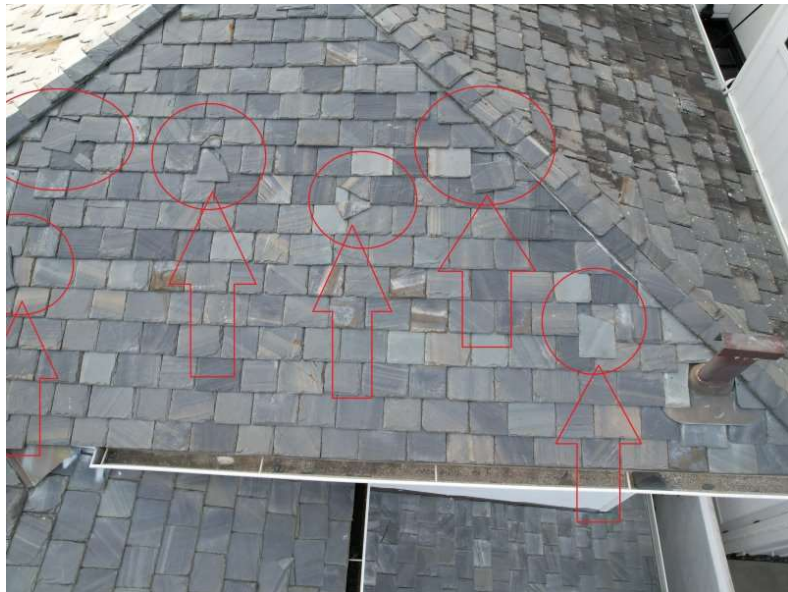
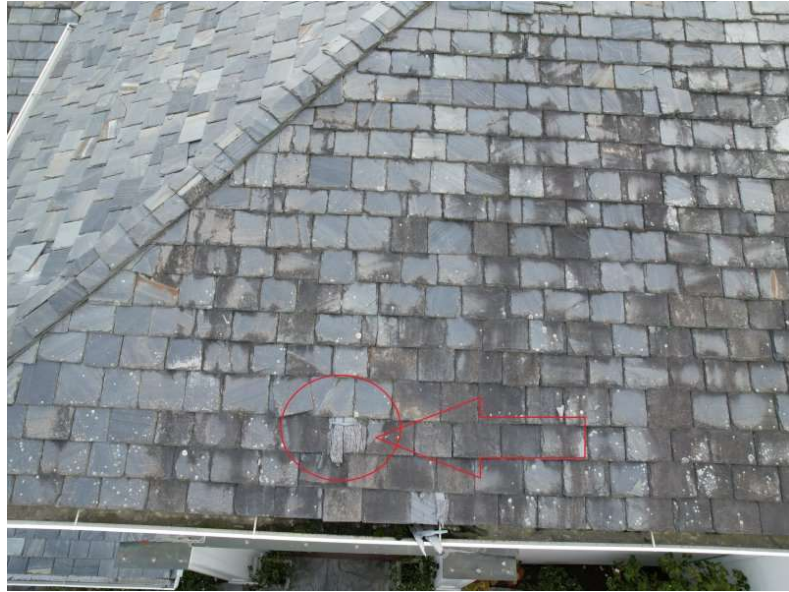
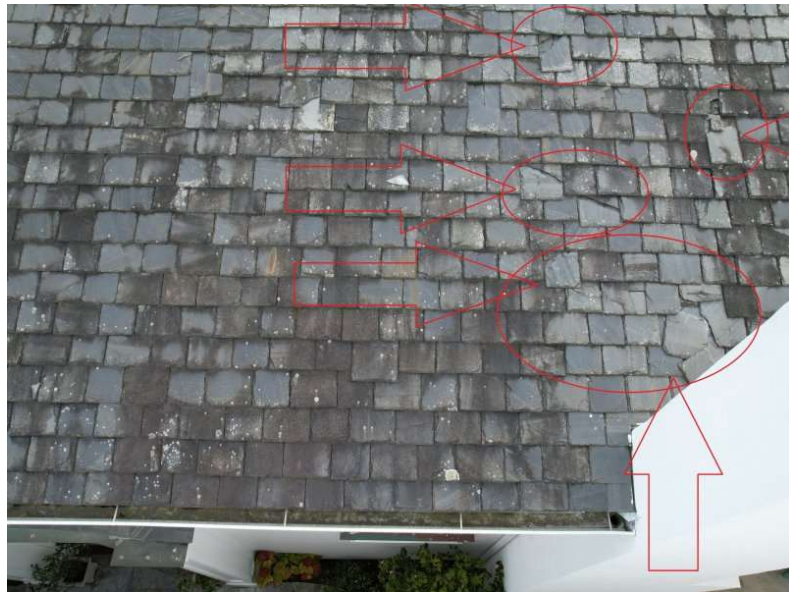
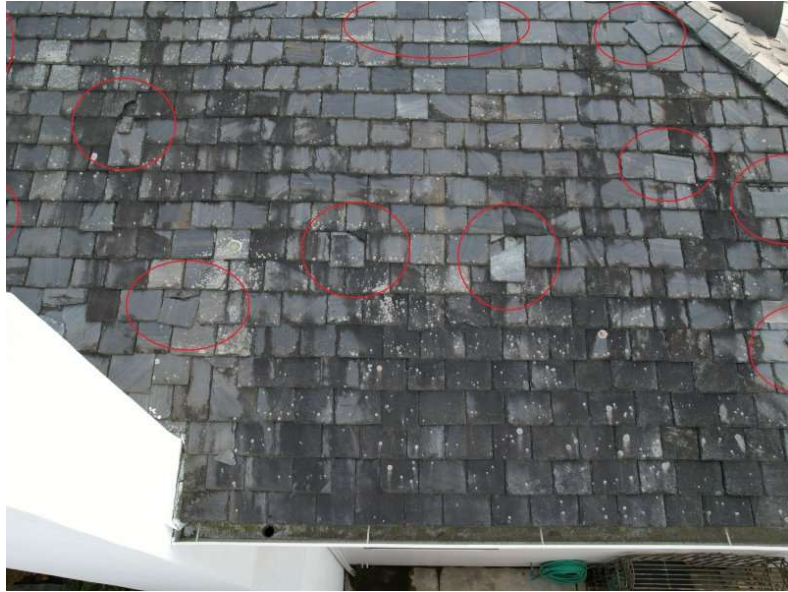
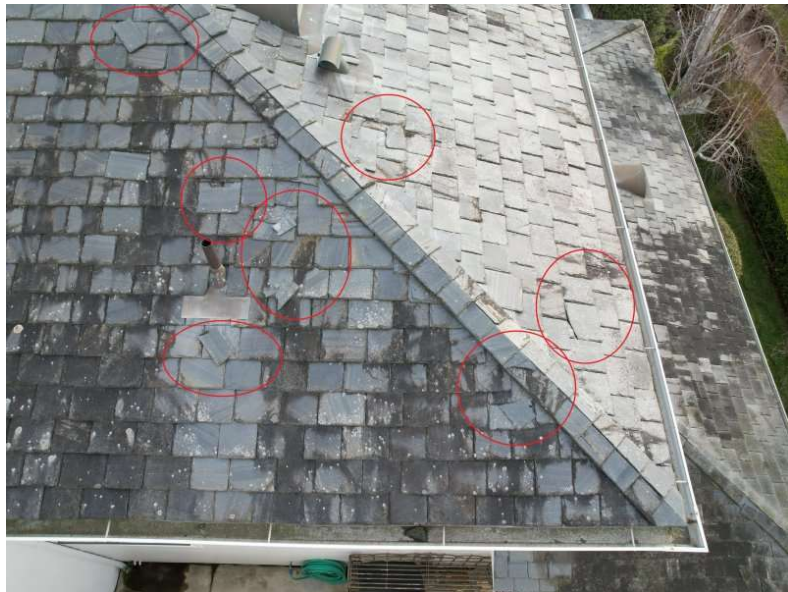
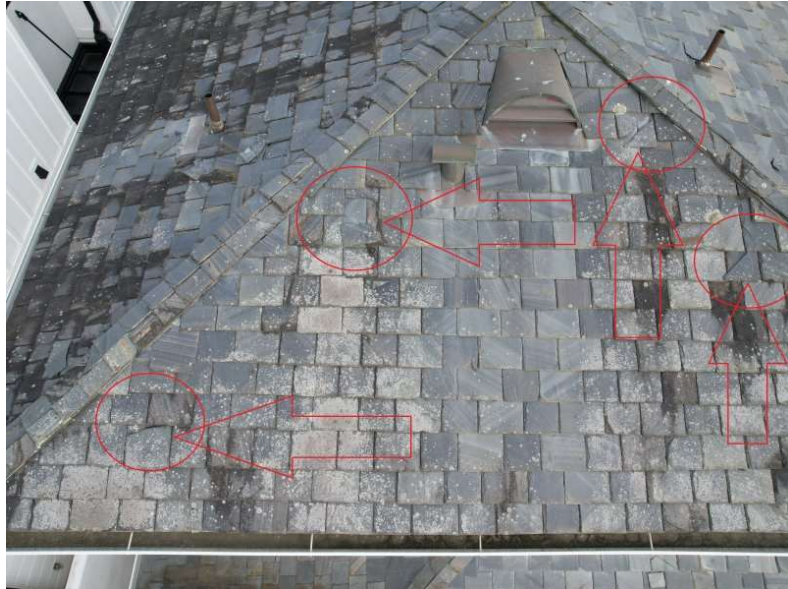
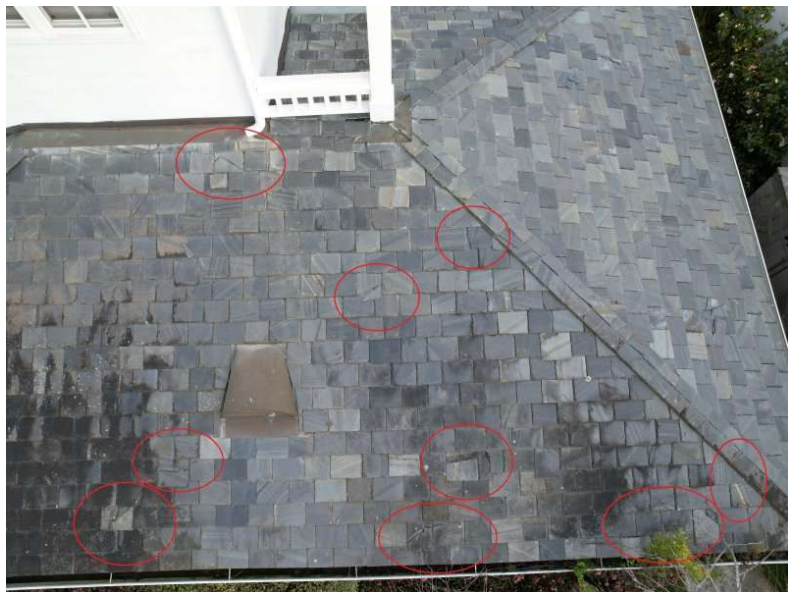
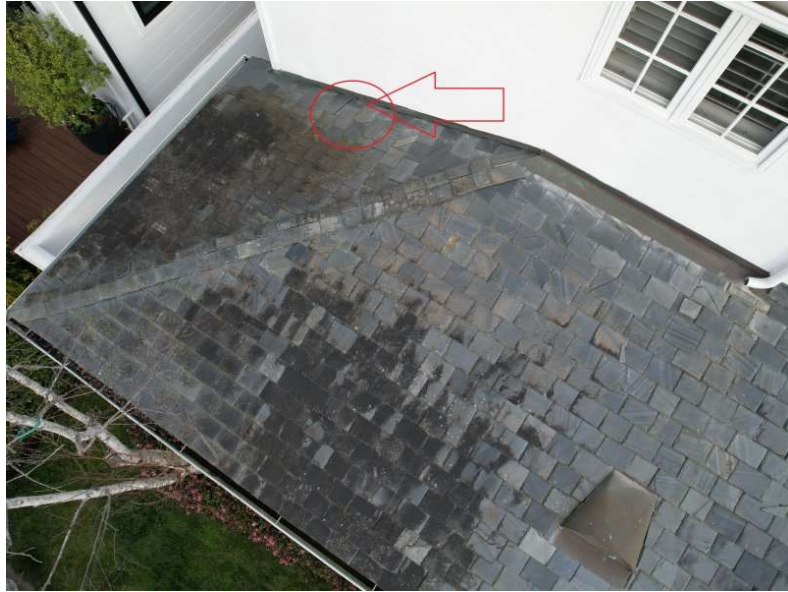
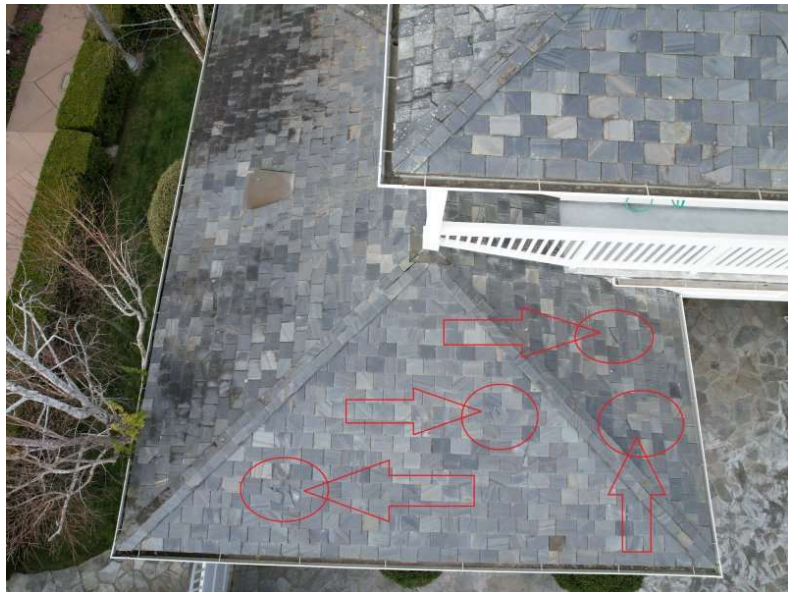
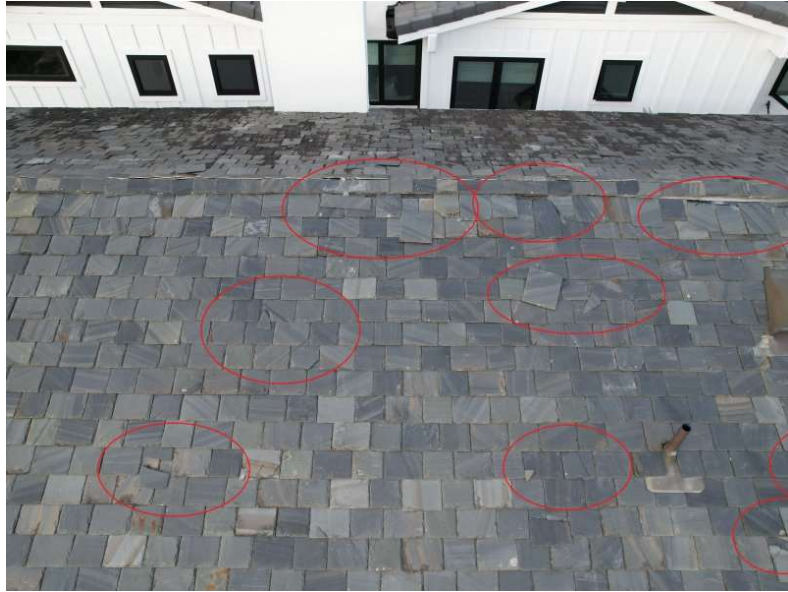
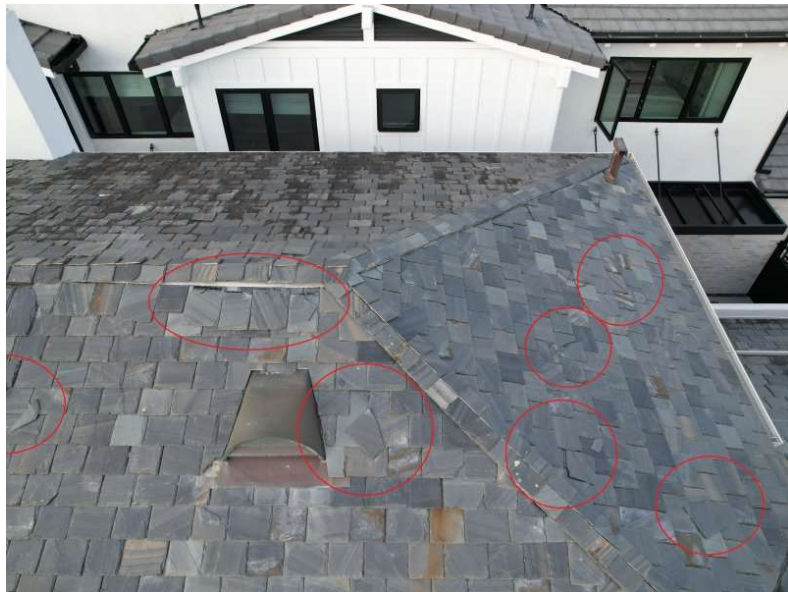
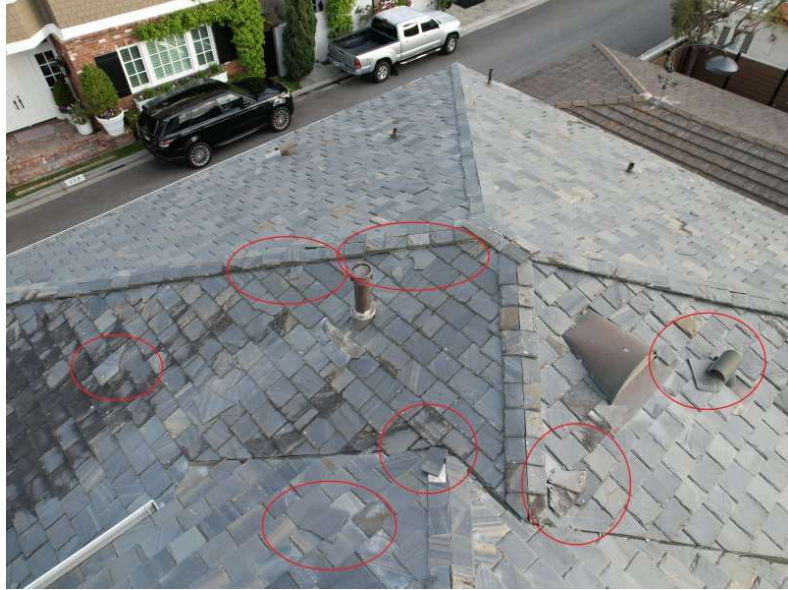
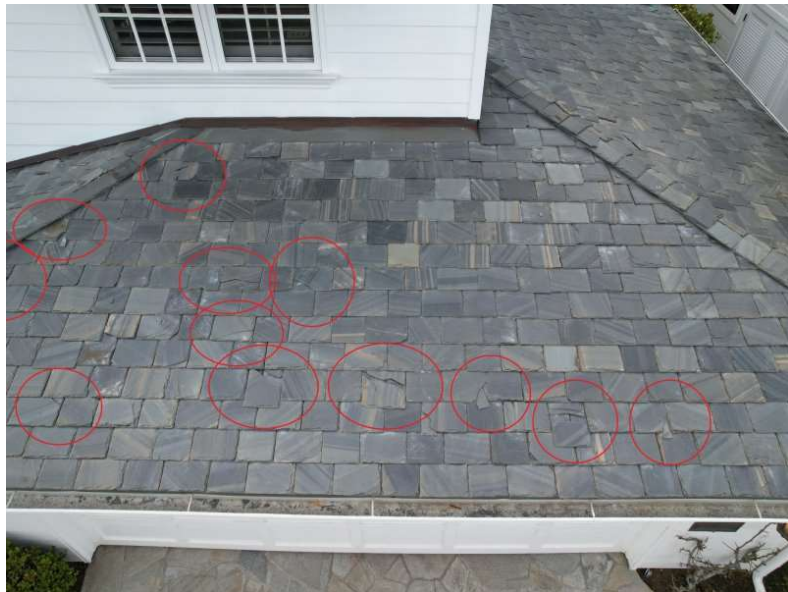
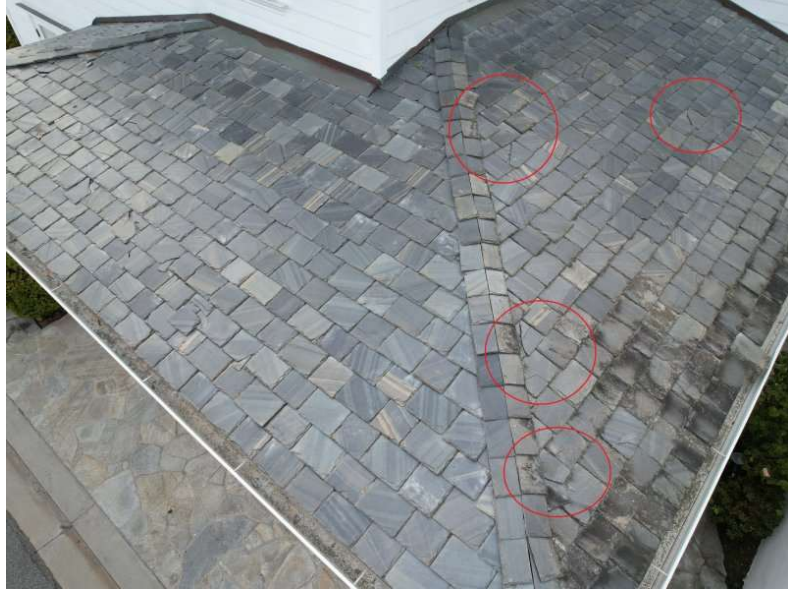
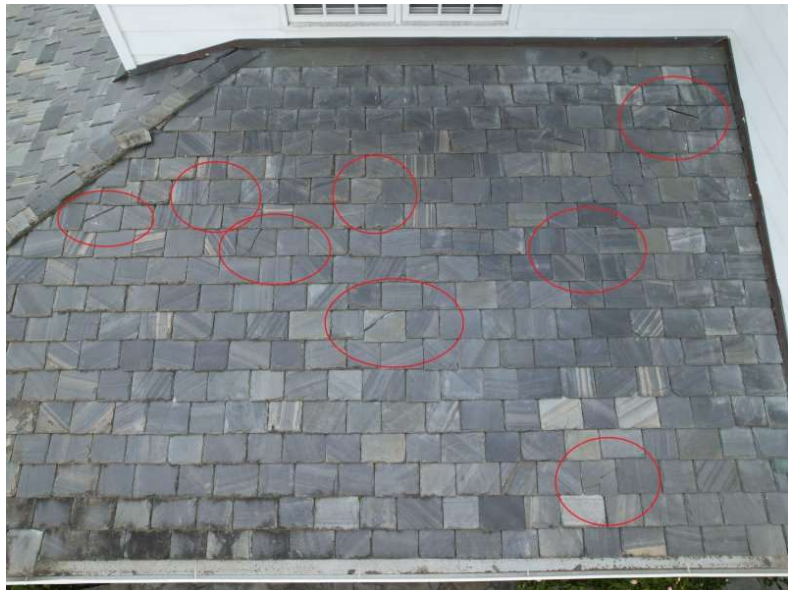
128.. Condition

Roof shows normal wear for its age and type. Cracked, chipped and slipped tiles noted. We suggest that maintenance efforts be made in the few areas where roofing materials are damaged or missing. Suggest consulting a licensed roofer for further review.

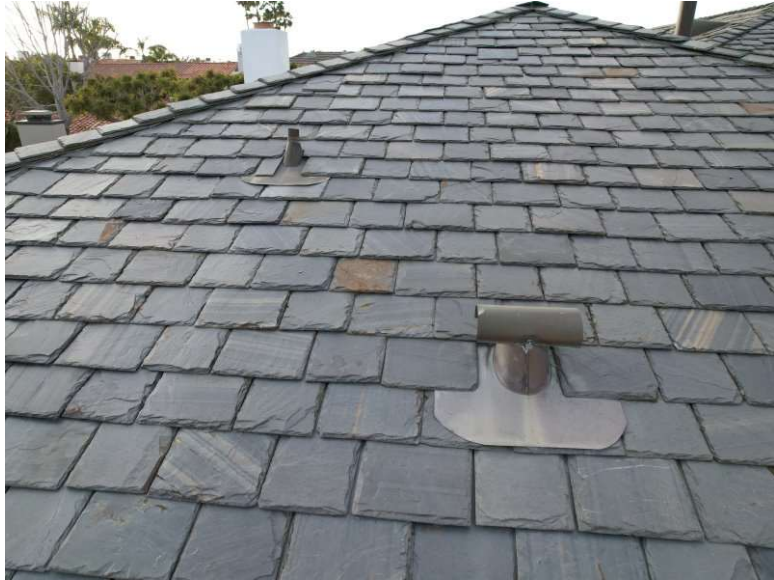
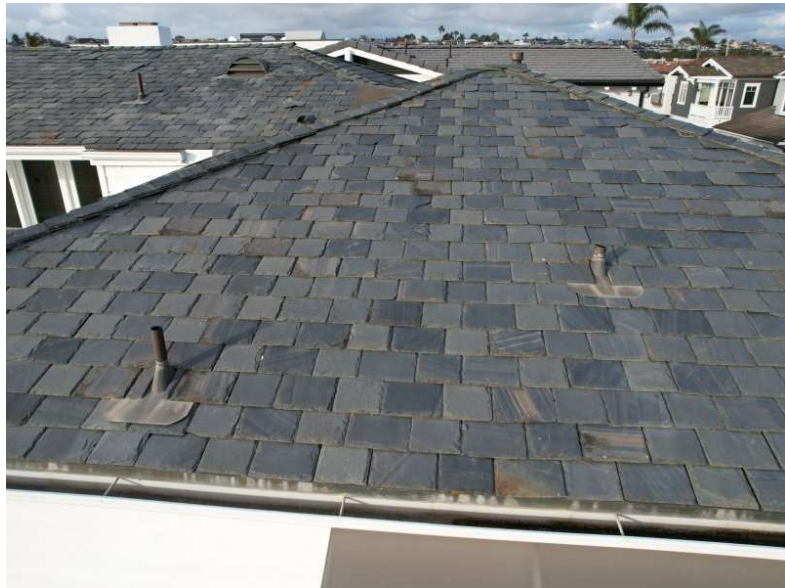
- 130.. Roof Penetrations Suggest re-sealing all through roof vents and projections as part of routine maintenance.
