**Orange Coast Property Services**

Doc #:	SAMPLE	Inspector:	Certified Inspector
Date:	1/2/2023		
Address:	123 S Main St Any City CA		
Client Name:	Mr. & Mrs. Buyer

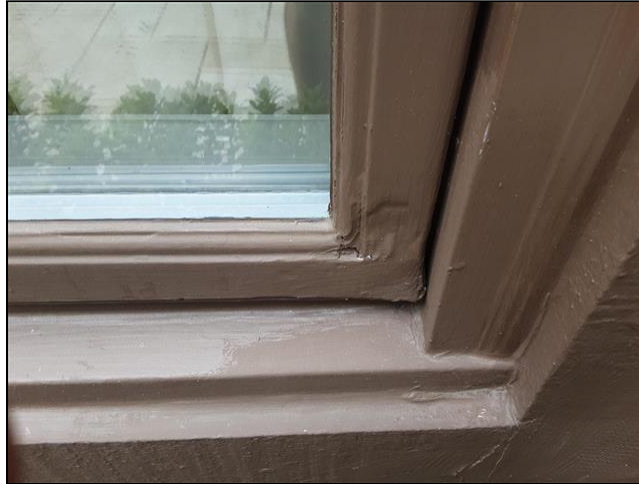
1.5 Window Frames **Condition: Deteriorated wood noted.**

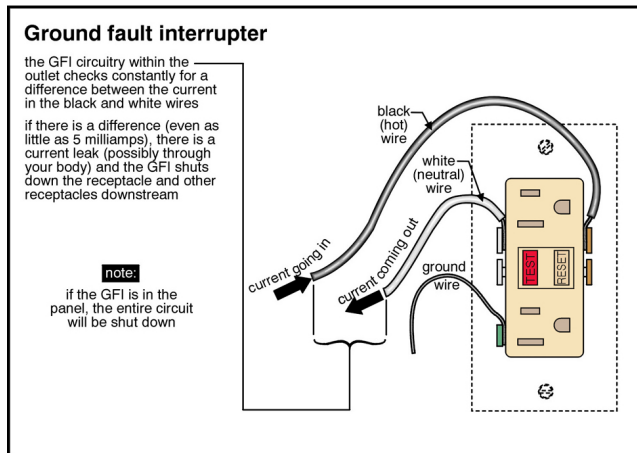
GFCI

1.6 Electrical **Serviceable. Ground fault circuit interrupters are provided for safety. We suggest periodic testing to ensure proper working order.**

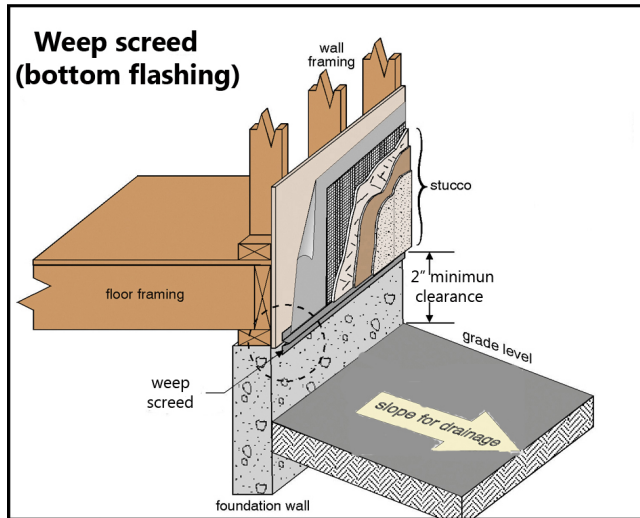
**WEEP SCREED**

**Home is built on a flat lot with a slope in the rear. Geological evaluations are beyond the scope of this report. We recommend consulting with a geotechnical engineer if concerned by conditions listed in this report or which you have observed. Grade at the foundation appears to be inadequate; Soil is above the weep screed (bottom flashing).**

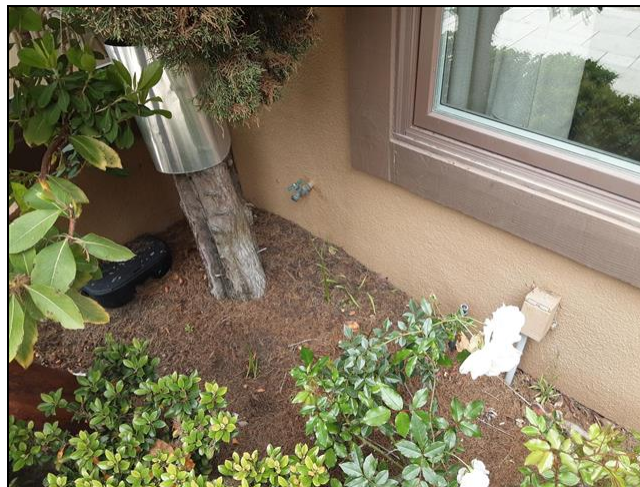
Condition:. Rusted gas lines noted.

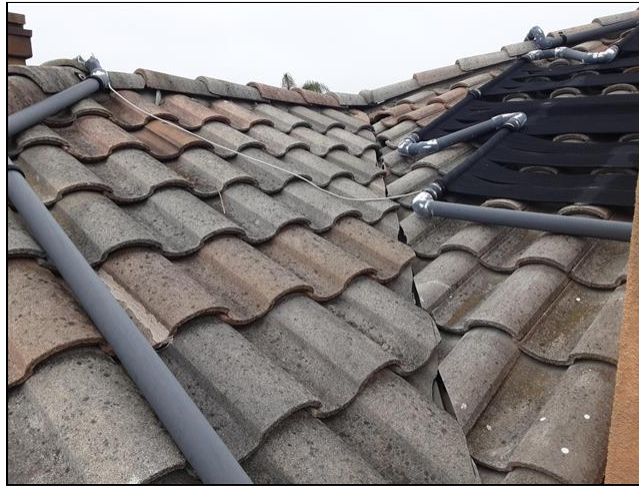
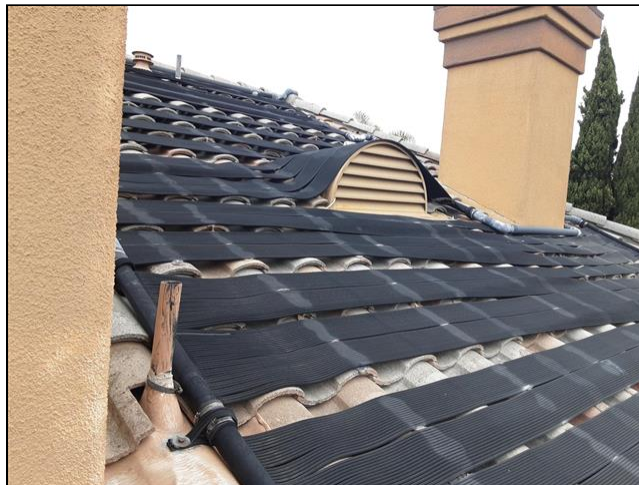
**Roof shows normal wear for its age and type; appears to be in serviceable condition. Roof was visually inspected from accessible points on the interior and/or exterior. If a roof is too high, is too steep, is wet, is part of an association or is composed of materials which can be damaged if walked upon, the roof is not mounted by inspector. Therefore, client is advised that this is a limited review and a licensed roofer should be contacted if a more detailed report is desired.**

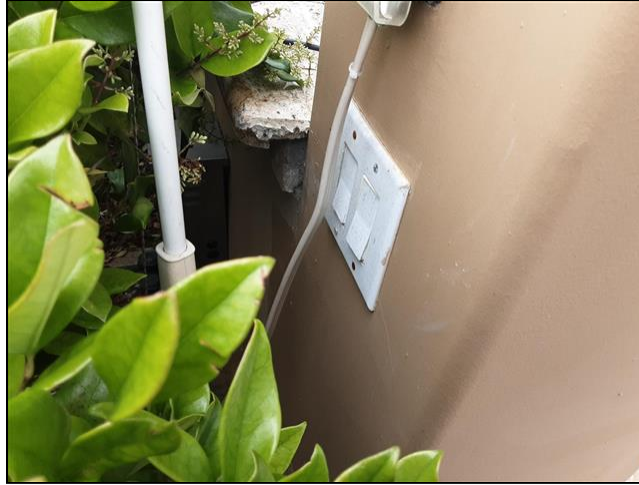
- 4.2 Electrical **Condition: Waterproof cover is not present at the switch, suggest replacing for safety.**
- Unable to test one outlet, weather cover is painted over.**
- Ground fault circuit interrupter is provided for safety. We suggest periodic testing to ensure proper working order.**

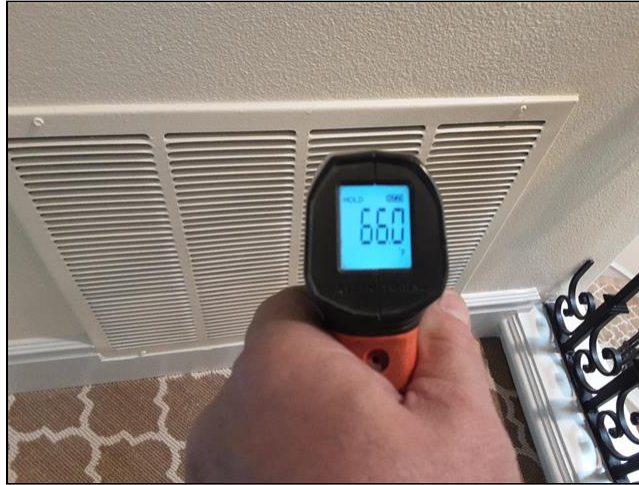
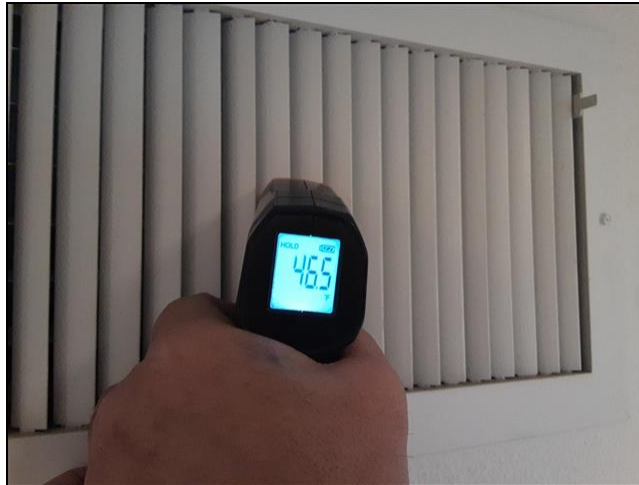
**Condition:.** Two compressors are located on the right side. Rust and deterioration noted on the compressor housing.

**66 ° noted at the intake; 46 ° noted at the register, units are cooling within guidelines.**

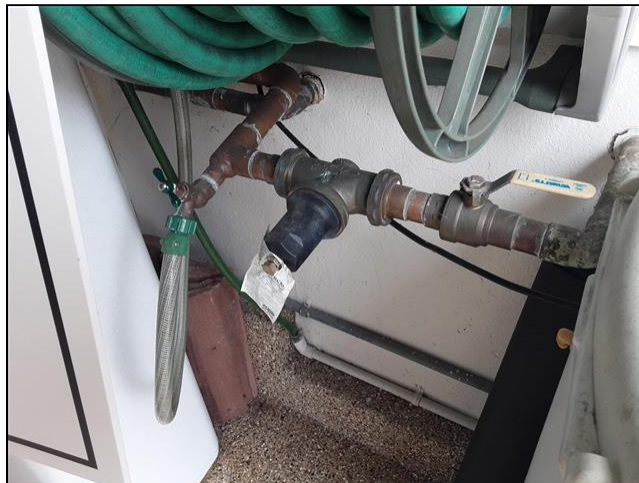
Step #	Component	Comment
8.0	Main Shut-off	<p><b>Main shut-off is located in the garage.</b></p> <p><b>The main water shut-off was not tested. These can fail at any time due to non-use and corrosion.</b></p>
8.1	Drain/Waste Vents	<b>S.</b>
8.2	Other Comments	<b>Pressure regulator and 60 psi noted.</b>

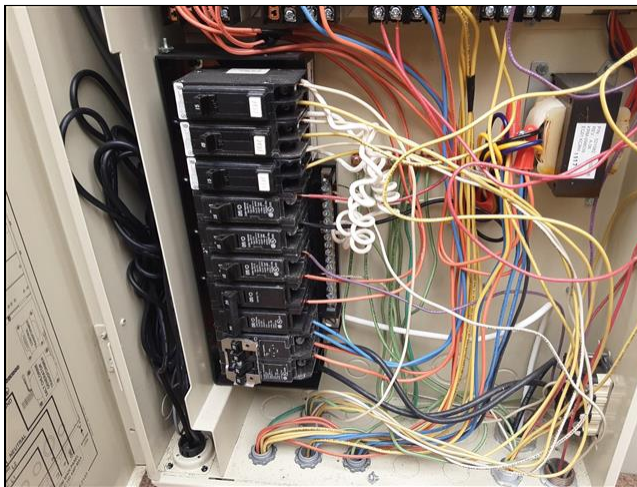
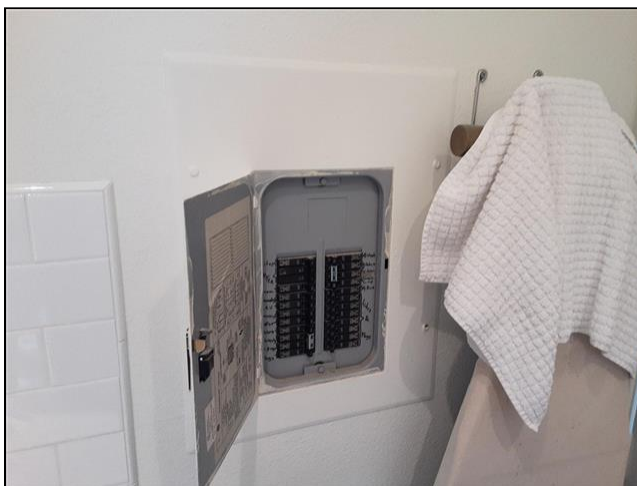
**Condition: Sub panel is located at the pool equipment and laundry room. Unable to access behind the sub panel cover, painted over.**

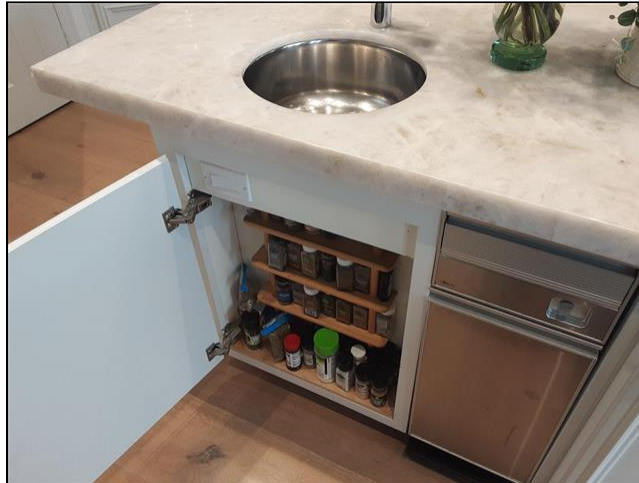
- 14.11 Traps/Drains/Supply **Condition:.** Unable to inspect under island sink, no access to drain lines.

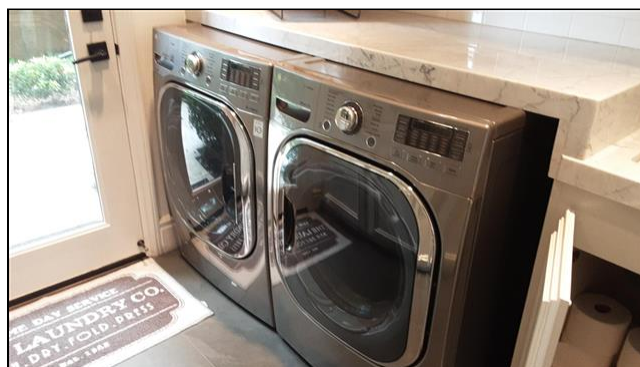
**Unable to fully inspect, blocked by machines.**

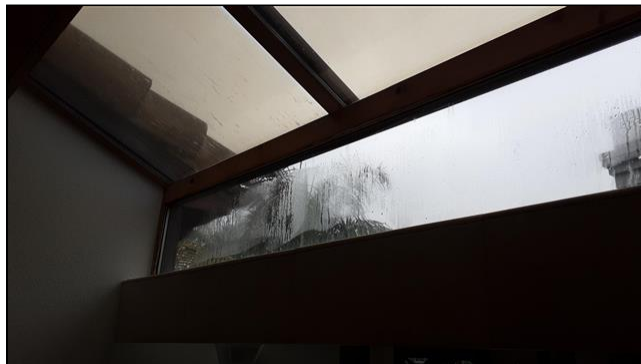
**Condensation was noted in the double insulated thermal windows, which will reduce visibility and the insulation capability of the window. To restore visibility and regain the insulating capability, replacement of the window may be required. Suggest further review with a window contractor.**

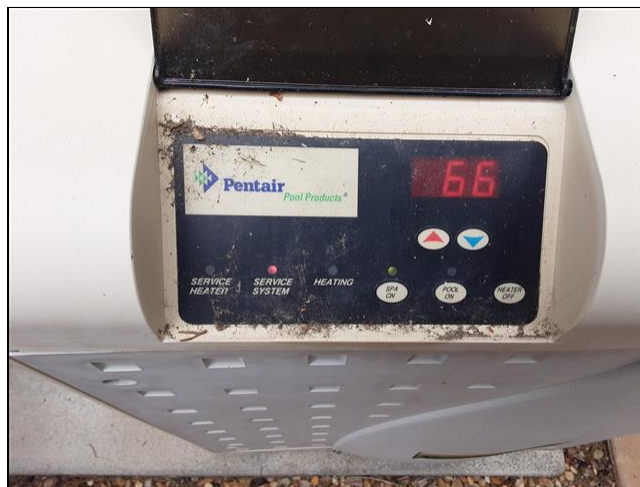
**Service indicator light is on, suggest further review with a pool/spa specialist.**

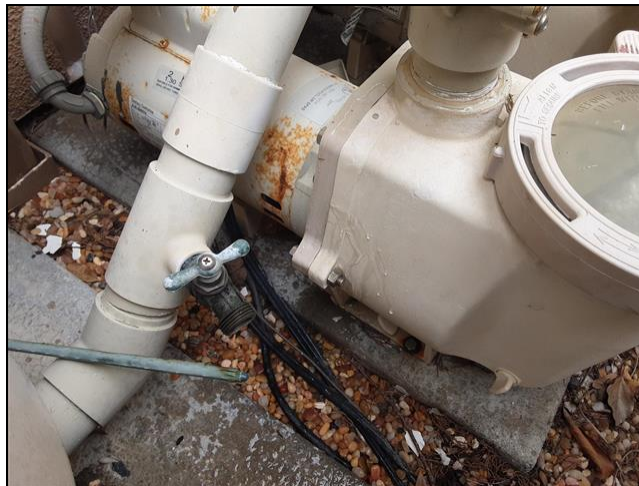
25.12 Pumps/Motors **Condition:. Leak noted, suggest further review with a specialist.**

**Rust noted at the housing.**
