**Orange Coast Property Services****South Coast Property Services****(949) 454-7900 -- (760) 585-2355**

| Doc #: | Thermal Sample | Inspector: | Certified Thermal Inspector |
| Address: | 123 Sample Street<br>Any Town CA 1111 | | |

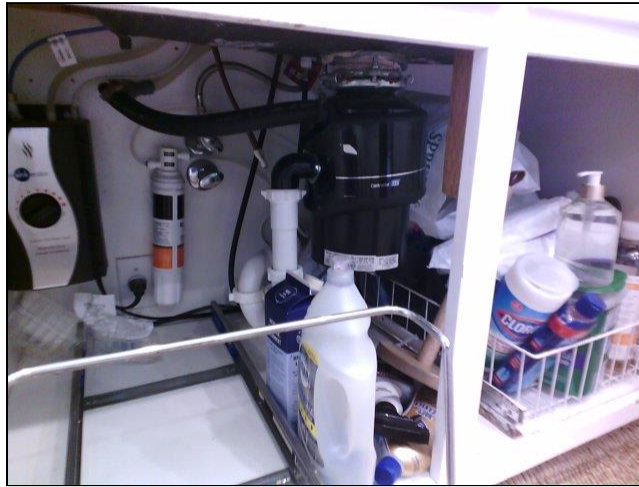
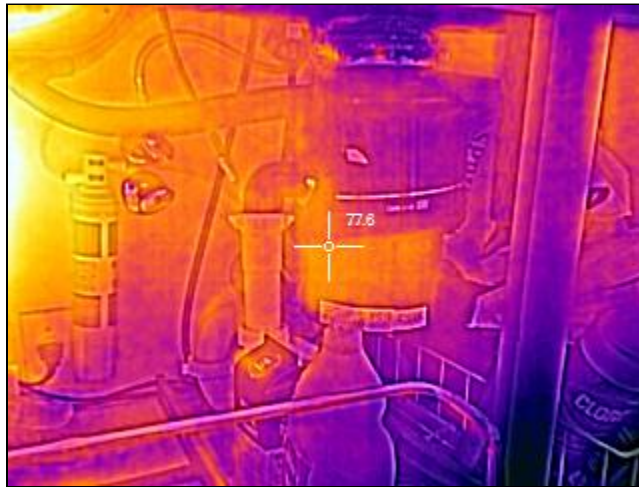
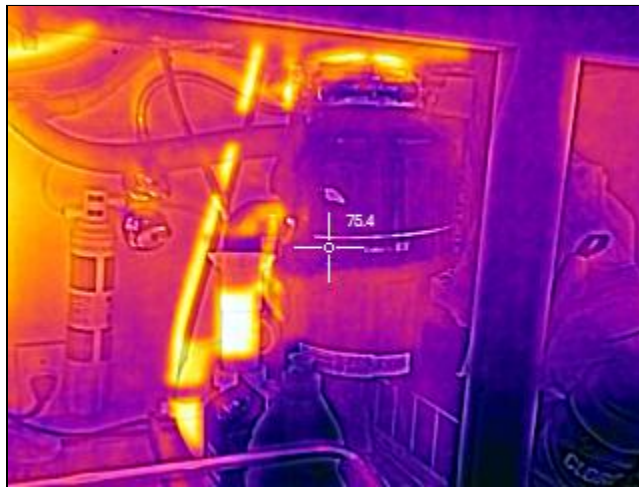
| Step # | Component | Comment |
|---|---|---|
| 2.0 | Traps/Drains/Supply | Pictures were taken before and after the water was run. No thermal anomalies were observed. |

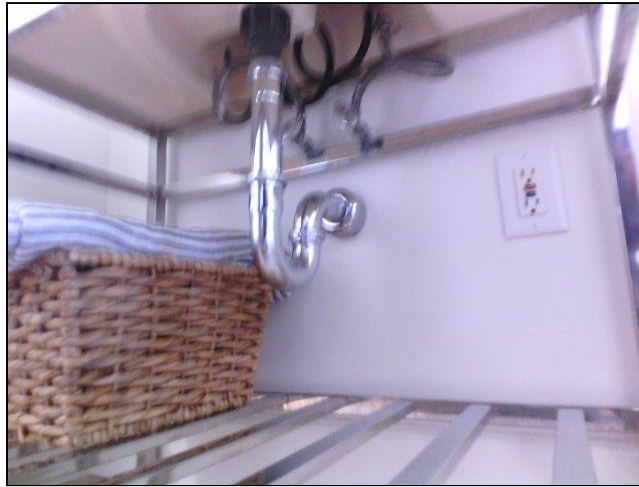
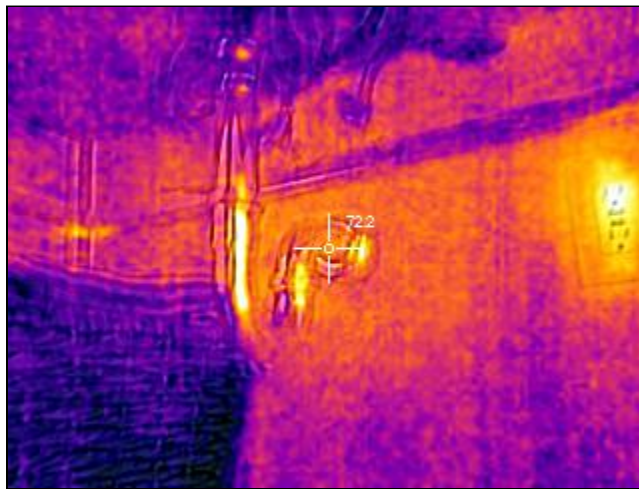
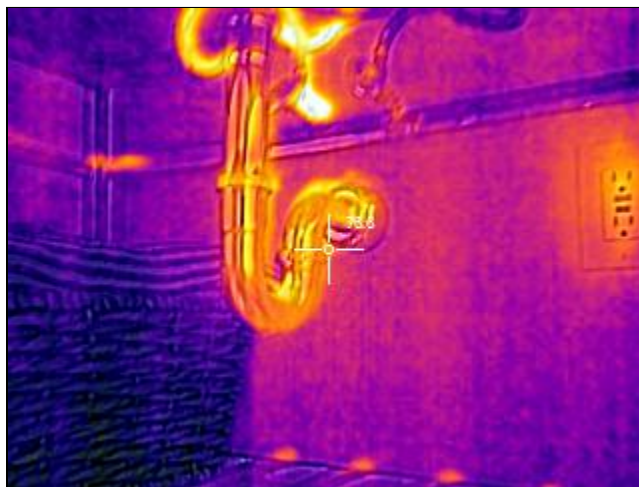
| Step # | Component | Comment |
|---|---|---|
| 3.0.A | Traps/Drains/Supply | Pictures were taken before and after the water was run. No thermal anomalies were observed. |

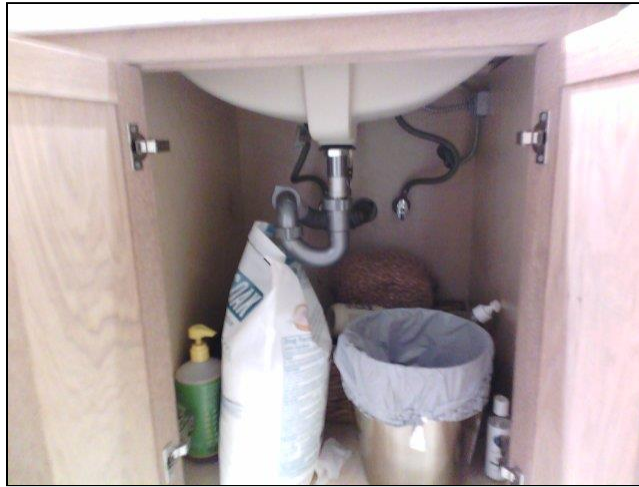
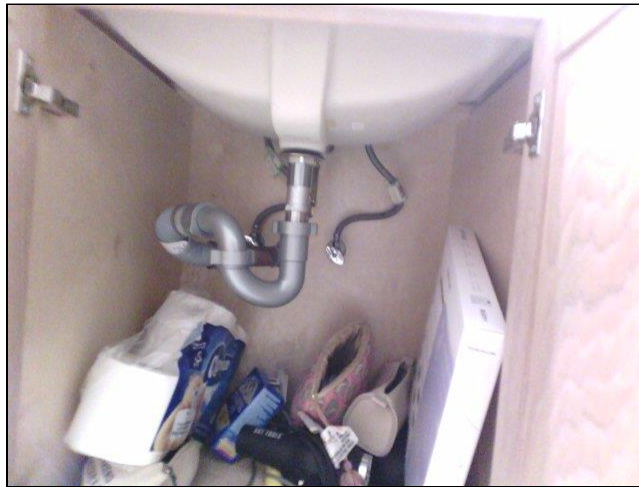
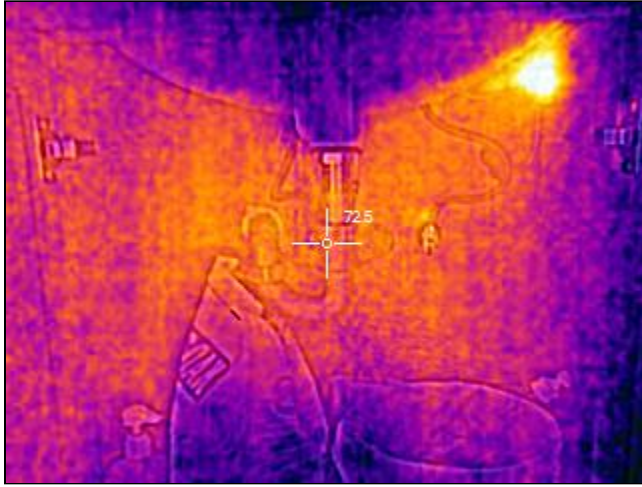
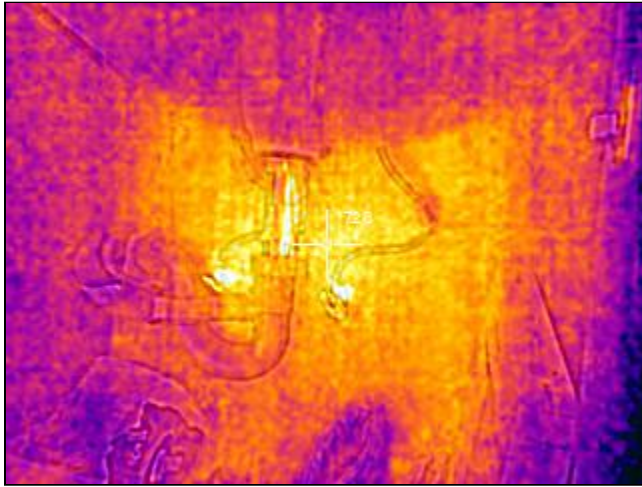
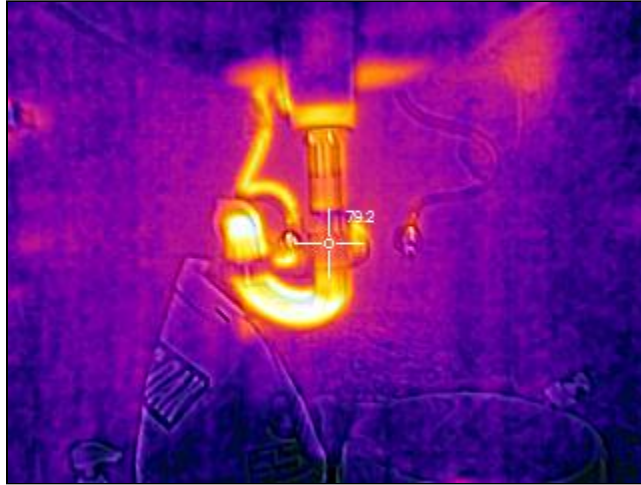
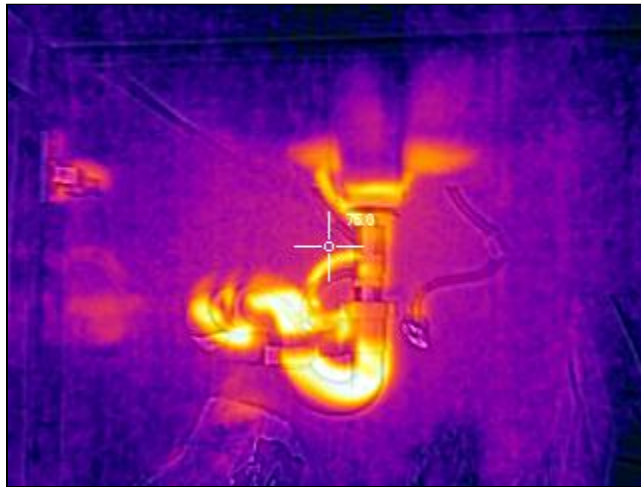
| Step # | Component | Comment |
|---|---|---|
| 3.0.B | Traps/Drains/Supply | Pictures were taken before and after the water was run. No thermal anomalies were observed. |

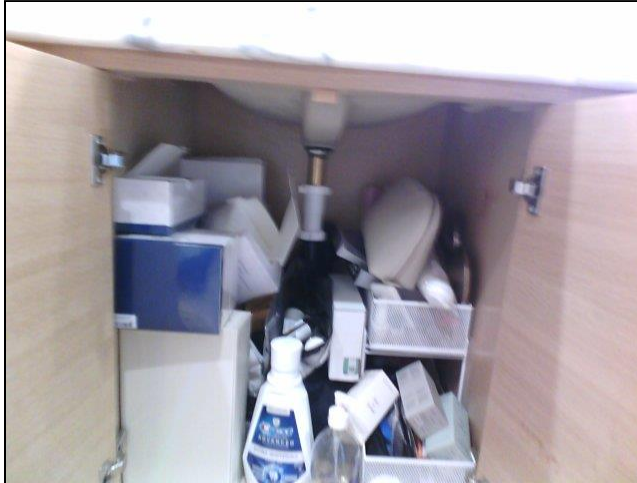
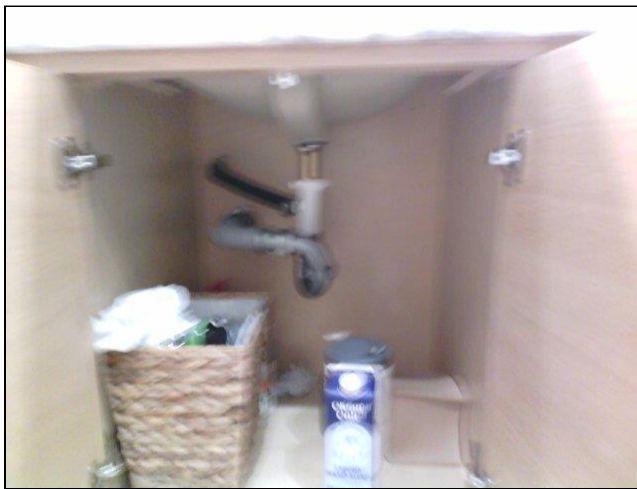
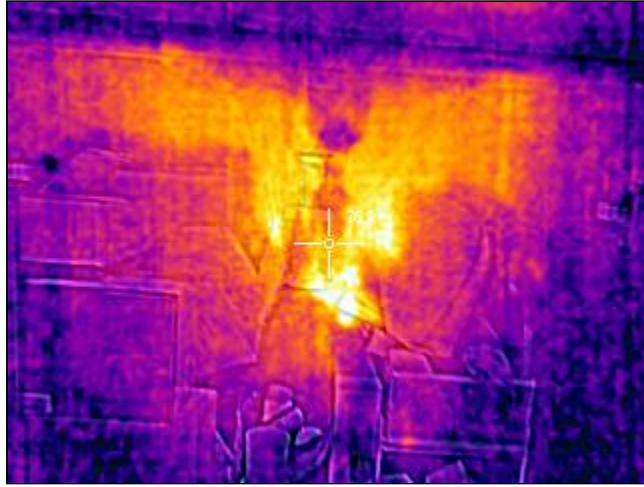
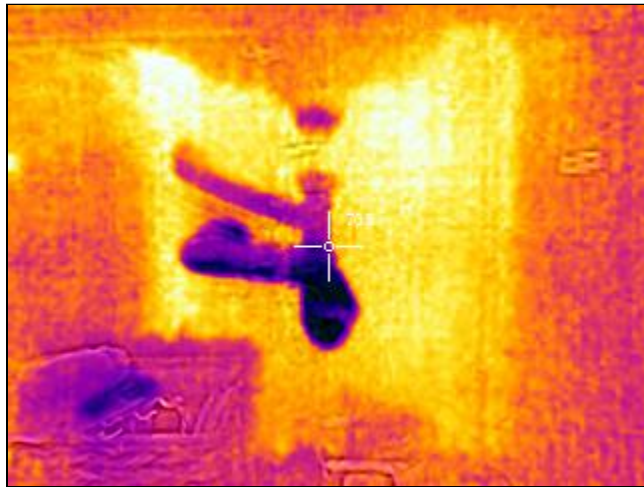
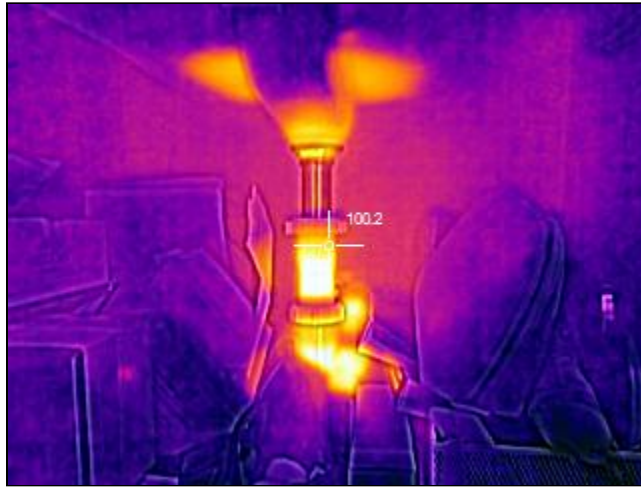
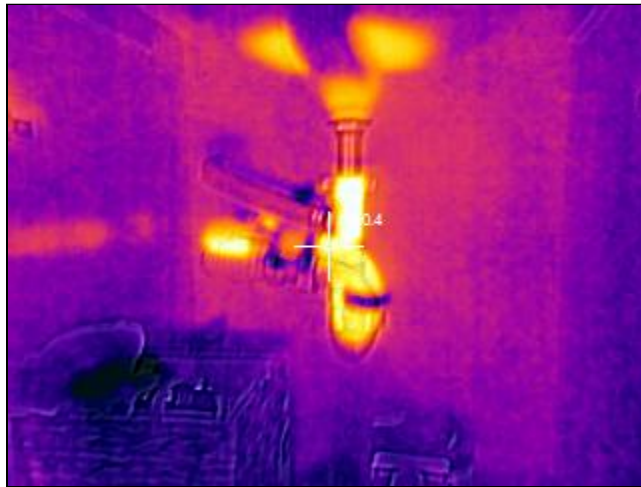
3.0.C Traps/Drains/Supply

**Pictures were taken before and after the water was run. No thermal anomalies were observed.**

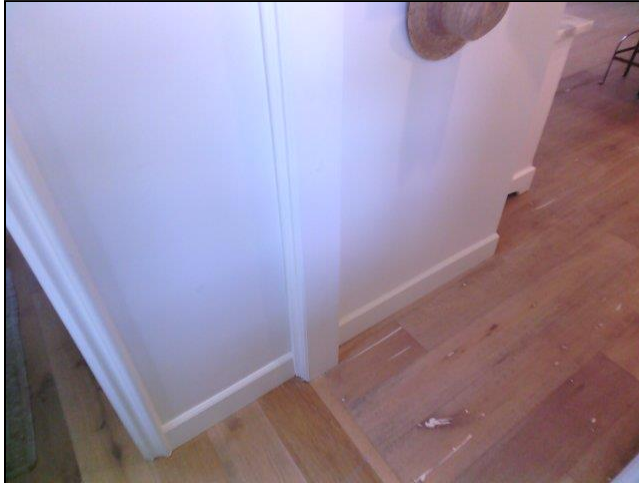
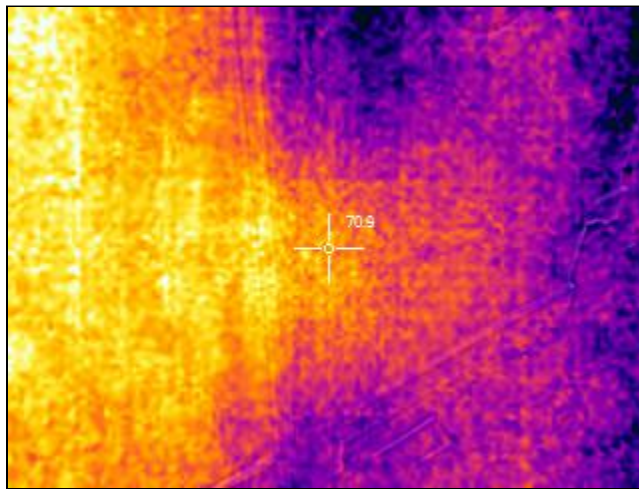
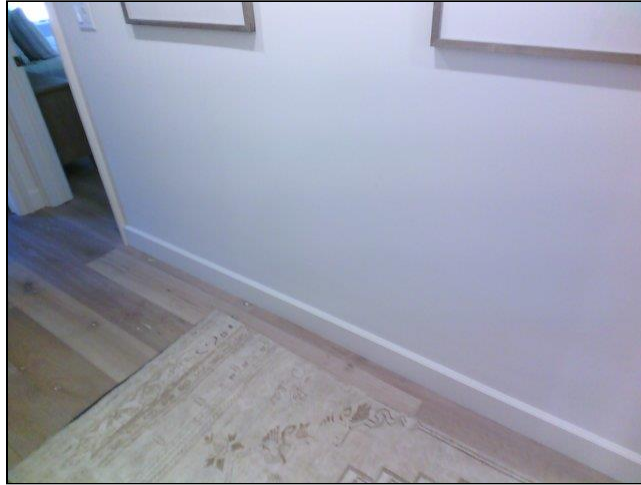
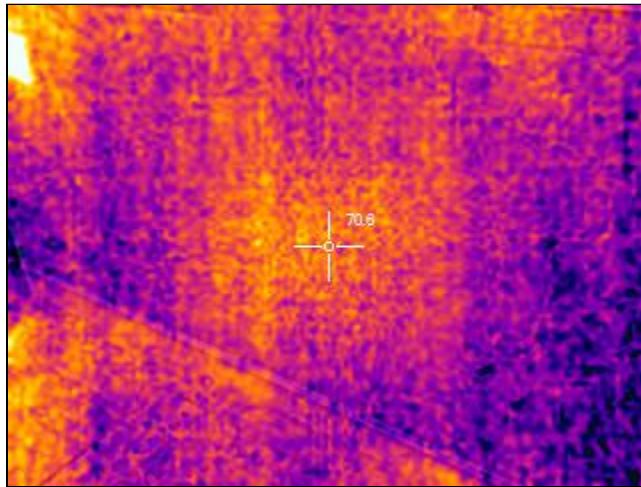
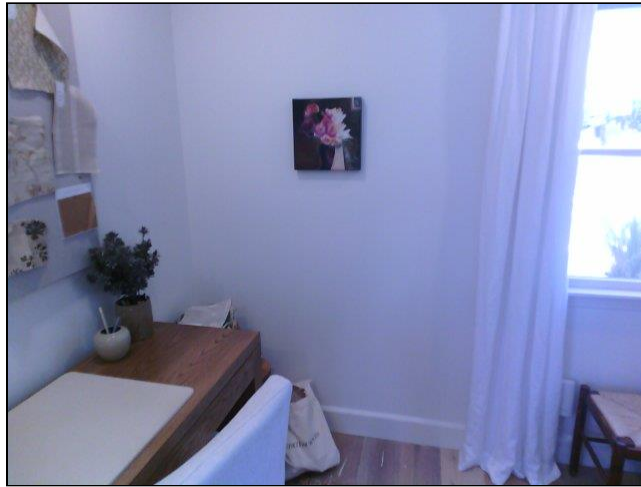
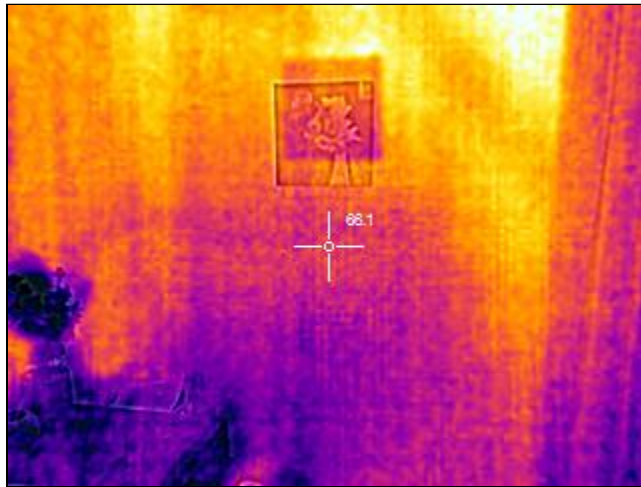
4.0 Walls

**Serviceable. Area was inspected with FLIR thermal camera, no thermal anomalies were detected.**
