Orange Coast Property Services

Doc #:	COMMERCIAL SAMPLE	Inspector:	Certified Inspector
Date:	9/27/2022		
Address:	123 Main Street Any Town CA		
Client Name:	Mr. Buyer

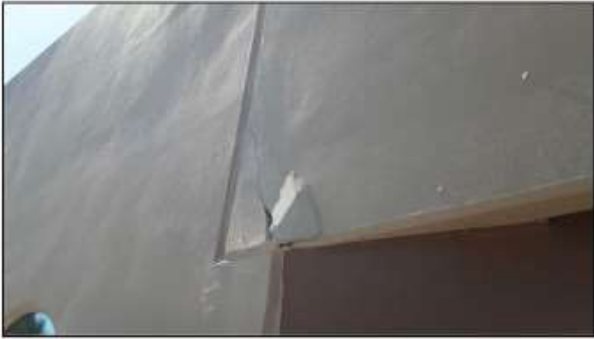
Step #	Component	Comment
1.0	Parking Lot	Condition: Cracked asphalt noted.
1.1	Walkways/Stairs	Condition: Common cracks and chipped concrete noted.
1.2	Walls/Fence/ Gates	N.
1.3	Siding	Condition: Damaged areas of stucco noted. Common cracks noted.

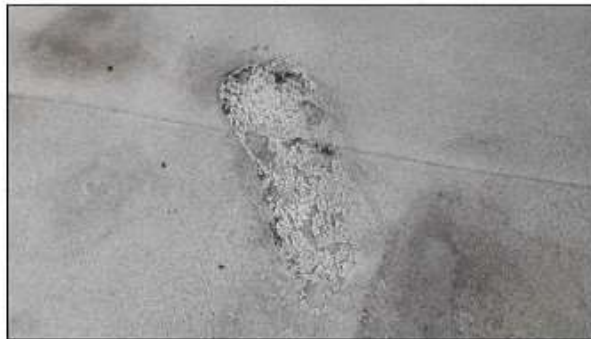
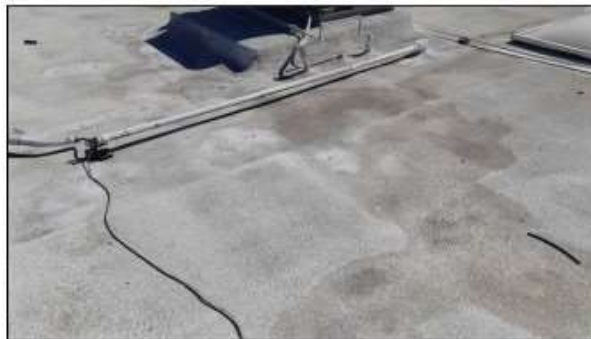
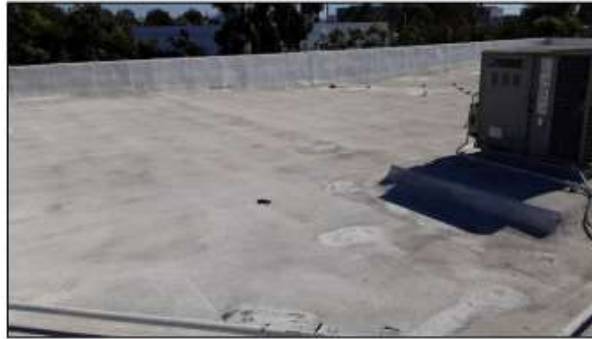
Step #	Component	Comment
2.0	Flashing	
2.1	Condition	Condition. Roof shows normal wear for its age and type. Evidence of ponding noted. This condition indicates improper drainage. Deteriorated composition noted. We suggest that the maintenance efforts be made in the few areas where roofing materials are damaged or missing. Suggest consulting a licensed roofer for further review.

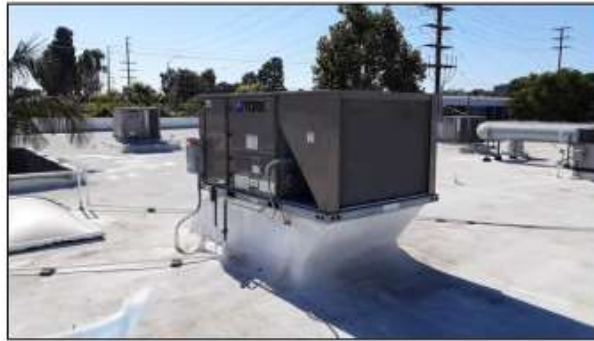
3.0 Heating **Condition: Unable to test per request of tenants.**

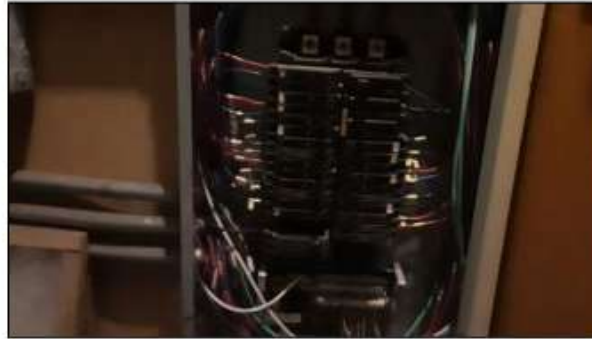
5.2 Sub Panel **Serviceable. Sub panel is located next to the main panel.**

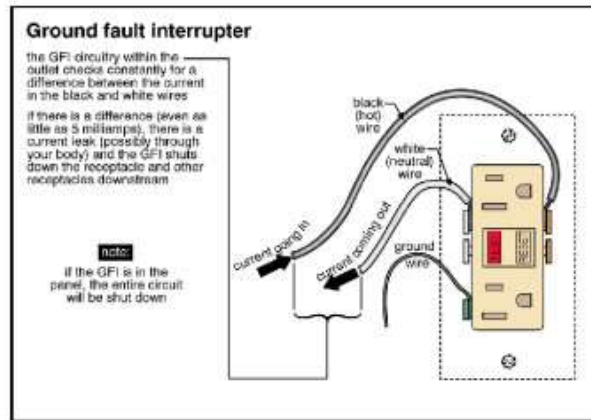
GFCI

Condition:. Ground fault circuit interrupters are provided for safety. We suggest periodic testing to ensure proper working order.

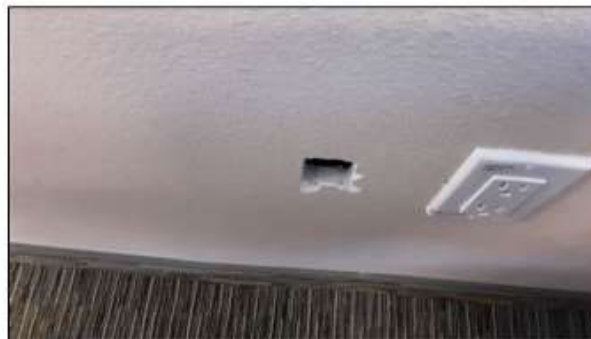
Step #	Component	Comment
9.0.E	Floors	S.
9.1.E	Walls	Condition:. Cut section noted.

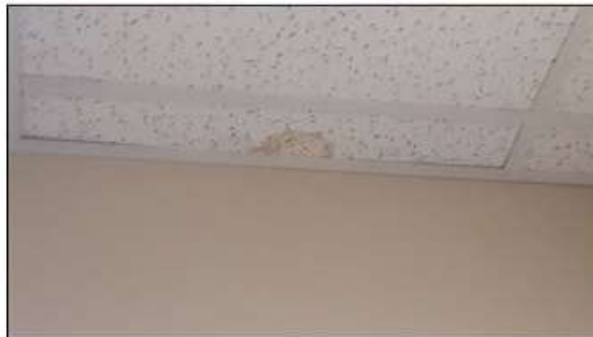
Step #	Component	Comment
10.0	Floors	S.
10.1	Walls	S.
10.2	Ceiling	Condition:. Water stains noted in rear storage closet, roof above.
